Access Compliance Report Public Rights-of-Way (Curb Ramps)

Intersection ID: 14156 Main Street: BEECH NUT RD Cross Street: HENDREN_AV Location: SE **ADA ID: 15FEEC64494E** Ramp Type: PerpDiag Initial Pass/Fail: Fail **Overall Compliance: No Severity Score:** 12.5

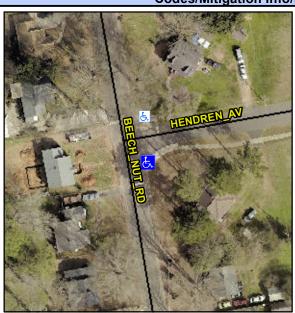
| Field Measurements/Component Compliance | | | | | | |
|---|---|--|---|---|---|---|
| | Yes | Ramp Width (in) | 48.0 | No | Ramp XSlope (%) | 5.3 |

HENDREN AV StopSign **BEECH NUT RD** StopSign Possible Solutions: Remove & Replace Curb Ramp With **Two New Directional Ramps or** Equivalent. Surveyor Notes: N/A PROW/ADA: R304.5.3
