Access Compliance Report Public Rights-of-Way (Curb Ramps)

Intersection ID: 50904	Main Street: KARRAS_COMMONS_WY			reet:	TILLEY_MORRIS_RD	Location:	NE		
ADA ID: 16069CE8FDDF	A ID: 16069CE8FDDF Ramp Type: Perp			Initial Pass/Fail: Fail Overall Compliance: No				o Severity Score:	8.75
Codes/Mitigation Info/Possible Solution			Field Measurements/Component Compliance						
Possible Solutions:								liance Description	Data
JE LI	- Martine I	Remove & Replace Entire Ramp		N/A	Ramp Length (in)	123.0	Yes	Ramp Slope (%)	6.1
				No	Ramp Width (in)	39.0	Yes	Ramp XSlope (%)	1.3
	a set and a		1	N/A	Flare Type LT	N/A	N/A	Flare Type RT	N/A
	The second second		I	N/A	Flare Slope LT (%)	N/A	N/A	Flare Slope RT (%)	N/A
	The Participant		I	N/A	Flare Traversable LT?	N/A	N/A	Flare Traversable RT?	N/A

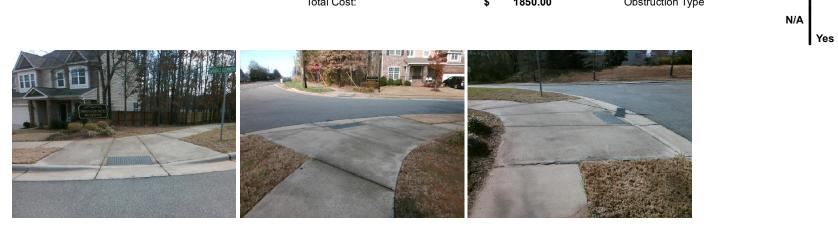
S. I BONYS	5	1	N/A	Landing Length (in)	N/A	N/A	DWS Provided?	N/A
	STONE WE	Surveyor Notes:	I	N/A	Landing Width (in)	N/A	N/A	DWS Contrast?	N/A
	and the second s	N/A	1	N/A	Landing Slope (%)	N/A	N/A	DWS Length (in)	N/A
and the second		1	I	N/A	Landing X Slope (%)	N/A	N/A	DWS Full Width?	N/A
TILL BY MOR	RIG PD		1	N/A	Landing Curb? (Y/N)	N/A	N/A	DWS Offset (in)	N/A
			1	N/A	Shared Landing?	N/A			
THE PERSON NEW TIME	-	PROW/ADA:	1	N/A	Gutter Ponding?	N/A	N/A	Gutter Slope (%)	N/A
Not Found, R304.5.1			1	N/A	Gutter Lip Ht (in)	N/A	N/A	Gutter X Slope (%)	N/A
the state of another	the second		1	N/A	Painted X Walk1?	No	N/A	Painted X Walk2?	N/A
					X Walk 1 Direction	To W		X Walk 2 Direction	N/A
			1	N/A	X Walk 1 Width (in)	N/A	N/A	X Walk 2 Width (in)	N/A
Street 1 Name KA	RRAS COMMONS WY	_			X Walk 1 Slope (%)	2.4		X Walk 2 Slope (%)	N/A
Stop Condition-Street 2	StopSign				X Walk 1 X Slope (%)	2.8		X Walk 2 X Slope (%)	N/A

Street 2 Name	N/A		I	N/A	Ramp inside XWalk1?	N/A	N/A	Ramp inside XWalk2?	N/A
Stop Condition-Street 1	N/A				Road Slope (%)	N/A	N/A	Clear Space?	N/A
					Road X Slope (%)	N/A	N/A	Clear Space to XWalk (in)	N/A
			I	N/A	Any Obstructions?	N/A	N/A	Storm Grate/Utility Hazard?	N/A
		Total Cost: \$	850.00		Obstruction Type			Storm Grate/Utility Type	
						N/A			N/A
