# Access Compliance Report

## Public Rights-of-Way

### (Curb Ramps)

Intersection ID: 8315	Main Street: BRADFORD_DR	Cross Street: HOVIS_RD	Location: W
ADA ID: 1608C0DE995E	Ramp Type: Perp	Initial Pass/Fail: Fail	Overall Compliance: No
			Severity Score: 13.75

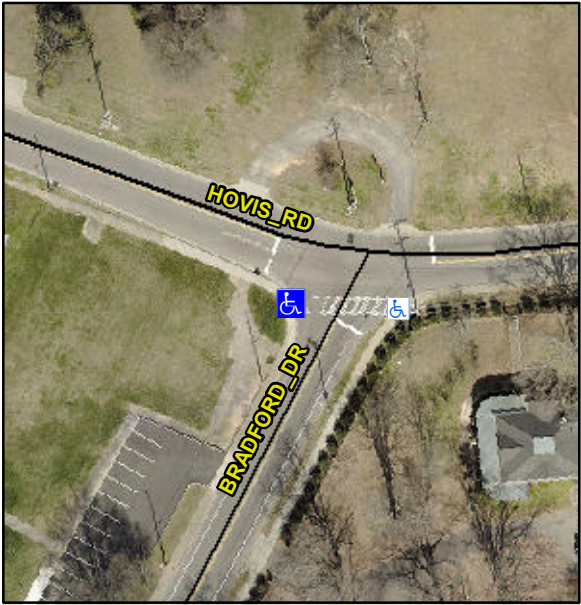
Possible Solutions:		<b>Compliance</b>	<b>Description</b>	<b>Data</b>
	Remove & Replace Entire Ramp.		N/A	Ramp Length (in)	59.0
			Yes	Ramp Width (in)	48.0
			N/A	Flare Type LT	N/A
			N/A	Flare Slope LT (%)	N/A
			N/A	Flare Traversable LT?	N/A
			N/A	Landing Length (in)	N/A
			N/A	Landing Width (in)	N/A
			N/A	Landing Slope (%)	N/A
			N/A	Landing X Slope (%)	N/A
<p>Surveyor Notes:</p> <p>N/A</p> <p>PROW/ADA:</p> <p>R304.2.2, R304.5.3</p>			N/A	Flare Type RT	N/A
			N/A	Flare Slope RT (%)	N/A
			N/A	Flare Traversable RT?	N/A
			N/A	DWS Provided?	N/A
			N/A	DWS Contrast?	N/A
			N/A	DWS Length (in)	N/A
			N/A	DWS Full Width?	N/A
			N/A	DWS Offset (in)	N/A
			N/A	Gutter Ponding?	N/A
			N/A	Gutter Lip Ht (in)	N/A
<p>Total Cost:</p> <p>\$ 1850.00</p>			N/A	Painted X Walk1?	Yes
			N/A	X Walk 1 Direction	To E
			N/A	X Walk 1 Width (in)	90.0

N/A	X Walk 1 Slope (%)	9.6
			N/A	X Walk 1 X Slope (%)	3.4
			N/A	Ramp inside XWalk1?	Yes
			N/A	Road Slope (%)	N/A
			N/A	Road X Slope (%)	N/A
			N/A	Any Obstructions?	N/A
			N/A	Obstruction Type	
			N/A	Clear Space?	N/A
			N/A	Clear Space to XWalk (in)	N/A
			N/A	Storm Grate/Utility Hazard?	N/A
			N/A	Storm Grate/Utility Type	
			N/A		N/A
			Yes	Surface Condition? (G/P)	Good
