Access Compliance Report Public Rights-of-Way (Curb Ramps)

Intersection ID: 28245	Main Street: SOCIETY_ST			Cross	Cross Street: COMMUNITY_HOUSE_RD				Location:	NE
ADA ID: 160CB50B3E35	Ramp Type: Perp			Initial	Initial Pass/Fail: Fail Overall Compliance: No				o Severity Score:	25
Codes/Mitigation Info/Possible Solution				Field Measurements/Component Compliance						
		Possible Solutions:		Compliance Description			Data Compliance Description			
		Remove & Replace Enti	re Ram	р.	N/A	Ramp Length (in)	96.0	No	Ramp Slope (%)	11.9
12 Martin And	State State	-			Yes	Ramp Width (in)	55.0	No	Ramp XSlope (%)	5.2
	AF INT				N/A	Flare Type LT	N/A	N/A	Flare Type RT	N/A
5	<u>ه</u> /				N/A	Flare Slope LT (%)	N/A	N/A	Flare Slope RT (%)	N/A
	all a				N/A	Flare Traversable LT?	N/A	N/A	Flare Traversable RT?	N/A
	<u>4</u>				N/A	Landing Length (in)	N/A	N/A	DWS Provided?	N/A
	23	Surveyor Notes:			N/A	Landing Width (in)	N/A	N/A	DWS Contrast?	N/A
the second		N/A			N/A	Landing Slope (%)	N/A	N/A	DWS Length (in)	N/A

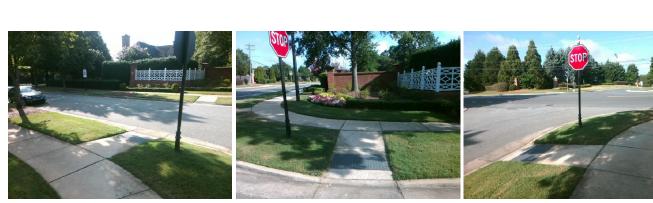
R. C.	PROW/ADA:			N/A	Gutter Ponding?	N/A	N/A	Gutter Slope (%)	N/A
. 6	c	Not Found, R304.2.2, R3	804.5.3		N/A	Gutter Lip Ht (in)	N/A	N/A	Gutter X Slope (%)	N/A
STORE () ()	10 10				N/A	Painted X Walk1?	No	N/A	Painted X Walk2?	N/A
						X Walk 1 Direction	To SE		X Walk 2 Direction	N/A
				N/A	X Walk 1 Width (in)	N/A	N/A	X Walk 2 Width (in)	N/A	
Street 1 Name	SOCIETY ST					X Walk 1 Slope (%)	1.9		X Walk 2 Slope (%)	N/A
Stop Condition-Street 2	StopSign					X Walk 1 X Slope (%)	3.2		X Walk 2 X Slope (%)	N/A
Street 2 Name	N/A				N/A	Ramp inside XWalk1?	N/A	N/A	Ramp inside XWalk2?	N/A
Stop Condition-Street 1	N/A					Road Slope (%)	N/A	N/A	Clear Space?	N/A
						Road X Slope (%)	N/A	N/A	Clear Space to XWalk (in)	N/A
					N/A	Any Obstructions?	N/A	N/A	Storm Grate/Utility Hazard?	N/A
		Total Cost:	\$	1850.00		Obstruction Type			Storm Grate/Utility Type	
							N/A			N/A
