Access Compliance Report

Public Rights-of-Way

(Curb Ramps)

Intersection ID: N/A	Main Street: S BREVARD ST	Cross Street: E 3RD ST	Location: S
ADA ID: 16217F4A8F54	Ramp Type: Perp	Initial Pass/Fail: Fail	Overall Compliance: No
			Severity Score: 22.5
Codes/Mitigation Info/Possible Solution		Field Measurements/Component Compliance

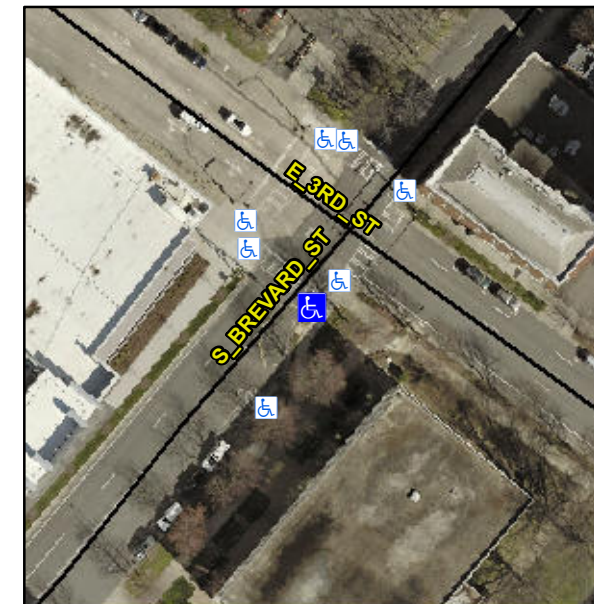
R304.5.1, R304.2.2, R304.5.3

Compliance	Description	Data	Compliance	Description	Data
N/A	Ramp Length (in)	72.0	No	Ramp Slope (%)	10.7
No	Ramp Width (in)	45.0	No	Ramp XSlope (%)	2.3
N/A	Flare Type LT	N/A	N/A	Flare Type RT	N/A
N/A	Flare Slope LT (%)	N/A	N/A	Flare Slope RT (%)	N/A
N/A	Flare Traversable LT?	No	N/A	Flare Traversable RT?	No
N/A	Landing Length (in)	N/A	N/A	DWS Provided?	N/A
N/A	Landing Width (in)	N/A	N/A	DWS Contrast?	N/A
N/A	Landing Slope (%)	N/A	N/A	DWS Length (in)	N/A
N/A	Landing X Slope (%)	N/A	N/A	DWS Full Width?	N/A
N/A	Landing Curb? (Y/N)	N/A	N/A	DWS Offset (in)	N/A
N/A	Shared Landing?	N/A			
N/A	Gutter Ponding?	N/A	N/A	Gutter Slope (%)	N/A
N/A	Gutter Lip Ht (in)	N/A	N/A	Gutter X Slope (%)	N/A
N/A	Painted X Walk1?	Yes	N/A	Painted X Walk2?	N/A
	X Walk 1 Direction	To NW		X Walk 2 Direction	N/A
N/A	X Walk 1 Width (in)	111.0	N/A	X Walk 2 Width (in)	N/A
	X Walk 1 Slope (%)	1.8		X Walk 2 Slope (%)	N/A
	X Walk 1 X Slope (%)	0.9		X Walk 2 X Slope (%)	N/A

N/A	Ramp inside XWalk1?	Yes	N/A	Ramp inside XWalk2?	N/A
	Road Slope (%)	N/A	N/A	Clear Space?	N/A
	Road X Slope (%)	N/A	N/A	Clear Space to XWalk (in)	N/A
N/A	Any Obstructions?	N/A	N/A	Storm Grate/Utility Hazard?	N/A
	Obstruction Type			Storm Grate/Utility Type	
		N/A			N/A
			Yes	Surface Condition? (G/P)	Good

Possible Solutions:

Remove & Replace Entire Ramp.
