Access Compliance Report Public Rights-of-Way (Curb Ramps)

Intersection ID: 45759	Main Street: LEONINE_CT		Cross	Cross Street: GRANDEUR_RD				Location: S	
ADA ID: 16348C744B6A	Ramp Type: PerpDiag		Initial	Initial Pass/Fail: Fail Overall Compliance			nce: N	o Severity Score:	21.25
Codes/Mitigation Info/Possible Solution				Field Measurements/Component Compliance					
Possible Solutions:				Compliance Description Data Compliance Description					Data
	LEONINE CT		\A/;+b	N/A	Ramp Length (in)	48.0	No	Ramp Slope (%)	8.4
		Remove & Replace Curb Ramp Two New Directional Ramps or	vvitri	No	Ramp Width (in)	40.0	Yes	Ramp XSlope (%)	0.4
		Equivalent.		N/A	Flare Type LT	41.0 N/A	N/A	Flare Type RT	0.5 N/A
				N/A	Flare Slope LT (%)	N/A		Flare Slope RT (%)	N/A N/A
					,		N/A	Flare Traversable RT?	
CARA STA				N/A	Flare Traversable LT?	N/A			N/A
				N/A	Landing Length (in)	N/A	N/A	DWS Provided?	N/A
		Surveyor Notes:		N/A	Landing Width (in)	N/A	N/A	DWS Contrast?	N/A
		N/A		N/A	Landing Slope (%)	N/A	N/A	DWS Length (in)	N/A

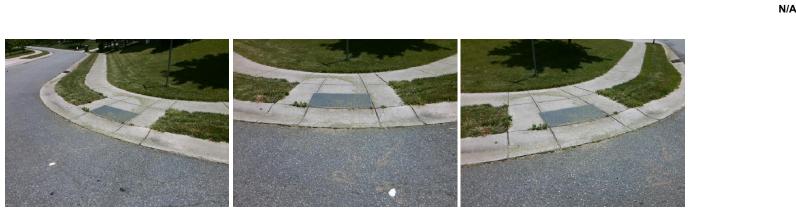
izer				N/A	Landing X Slope (%)	N/A	N/A	DWS Full Width?	N/A
				N/A	Landing Curb? (Y/N)	N/A	N/A	DWS Offset (in)	N/A
	A PLON			N/A	Shared Landing?	N/A			
		PROW/ADA:		N/A	Gutter Ponding?	N/A	N/A	Gutter Slope (%)	N/A
		Not Found, R304.5.1, R304.2.2		N/A	Gutter Lip Ht (in)	N/A	N/A	Gutter X Slope (%)	N/A
	VA.			N/A	Painted X Walk1?	No	N/A	Painted X Walk2?	No
	A WAR				X Walk 1 Direction	To NE		X Walk 2 Direction	To NW
	AN AND	2		N/A	X Walk 1 Width (in)	N/A	N/A	X Walk 2 Width (in)	N/A
Street 1 Name	LEONINE CT				X Walk 1 Slope (%)	5.9		X Walk 2 Slope (%)	4.4
Stop Condition-Street 2	StopSign				X Walk 1 X Slope (%)	2.6		X Walk 2 X Slope (%)	3.1
Street 2 Name	GRANDEUR RD			N/A	Ramp inside XWalk1?	N/A	N/A	Ramp inside XWalk2?	N/A
Stop Condition-Street 1	None				Road Slope (%)	2.5	N/A	Clear Space?	N/A
					Road X Slope (%)	5.6	N/A	Clear Space to XWalk (in)	N/A
				N/A	Any Obstructions?	N/A	N/A	Storm Grate/Utility Hazard?	N/A

Total Cost: \$	3200.00		Obstruction Type			Storm Grate/Utility Type	
		· · · · · · · · · · · · · · · · · ·				N/A			N/A
							1
