# Access Compliance Report

## Public Rights-of-Way

### (Curb Ramps)

| Intersection ID: 48452 | Main Street: RED_RUST_LN | Cross Street: BURNT_LEATHER_LN | Location: NE |

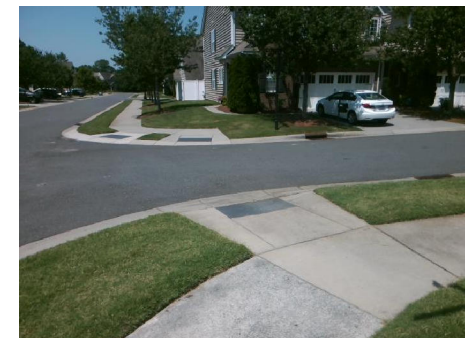
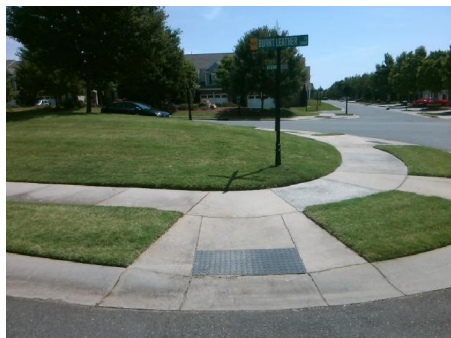
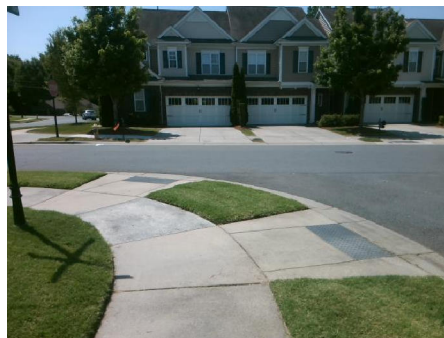
| ADA ID: 1660858AF074 | Ramp Type: BlendTrans2 | Initial Pass/Fail: Fail | Overall Compliance: No |

**Not Found, R304.5.1, R304.5.3**

| Compliance | Description | Data | Compliance | Description | Data |
|---|---|---|---|---|---|
| No | Ramp Width (in) | 46.5 | No | BlendTrans XSlope (%) | 3.5 |
| | | | No | Curb Slope (%) | 8.3 |

**Remove & Replace Curb Ramp With Two New Directional Ramps or Equivalent.**

Total Cost: \$ 3200.00
