Access Compliance Report

Public Rights-of-Way

(Curb Ramps)

Intersection ID: 14441	Main Street: E_KINGSTON_AV	Cross Street: SPRINGDALE_AV	Location: W
ADA ID: 16684A1E7941	Ramp Type: Directional1	Initial Pass/Fail: Fail	Overall Compliance: No
			Severity Score: 28.75

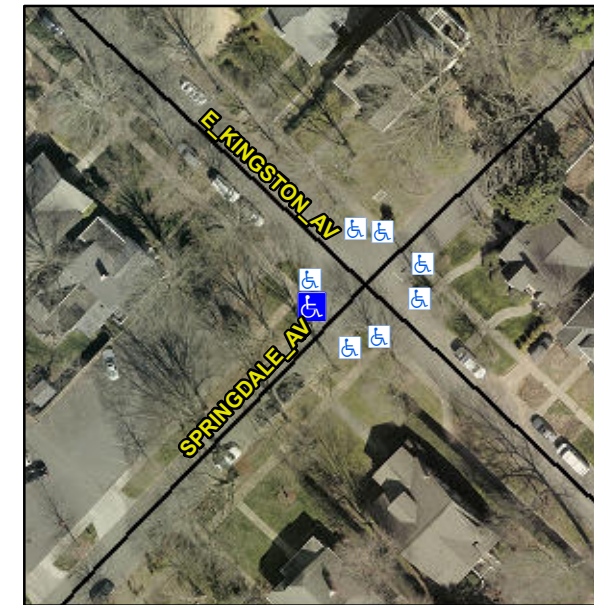
DAMAGED CURB/GTR/RAMP

R304.2.2, R304.5.3, R302.7

Compliance	Description	Data	Compliance	Description	Data
N/A	Ramp Length (in)	99.0	N/A	Grade Break?	N/A
Yes	Ramp Width (in)	48.0	N/A	Grade Break Slope (%)	0.0
No	Ramp Slope (%)	8.7	N/A	Grade Break XSlope (%)	0.0
No	Ramp XSlope (%)	2.4			
N/A	Flare Type LT	N/A	N/A	Flare Type RT	N/A
N/A	Flare Slope LT (%)	N/A	N/A	Flare Slope RT (%)	0.0
N/A	Flare Traversable LT?	N/A	N/A	Flare Traversable RT?	N/A
N/A	Landing Length (in)	0.0	N/A	DWS Provided?	N/A
N/A	Landing Width (in)	0.0	N/A	DWS Contrast?	N/A
N/A	Landing Slope (%)	0.0	N/A	DWS Length (in)	N/A
N/A	Landing X Slope (%)	0.0	N/A	DWS Full Width?	N/A
N/A	Landing Curb? (Y/N)	N/A	N/A	DWS Offset LT (in)	N/A
N/A	Shared Landing?	N/A	N/A	DWS Offset RT (in)	N/A
N/A	Gutter Ponding?	0.0	N/A	Gutter Slope (%)	N/A
N/A	Gutter Lip Ht (in)	1.0	N/A	Gutter X Slope (%)	N/A
N/A	Painted X Walk1?	No		Road Slope (%)	1.1
	X Walk 1 Direction	To SE		Road X Slope (%)	2.9
	X Walk 1 Width (in)	N/A		Clear Space?	N/A

X Walk 1 Slope (%)	1.1	N/A	Clear Space to XWalk (in)	N/A
	X Walk 1 X Slope (%)	2.9	N/A	Storm Grate/Utility Hazard?	N/A
N/A	Ramp inside XWalk1?	N/A		Storm Grate/Utility Type	
N/A	Any Obstructions?	N/A			N/A
	Obstruction Type		No	Surface Condition? (G/P)	Poor
			N/A	Curb Slope (%)	12.7

Remove & Replace Entire Ramp.
