# Access Compliance Report

## Public Rights-of-Way

### (Curb Ramps)

Intersection ID: N/A	Main Street: PROVIDENCE_RD	Cross Street: N/A	Location: SE
ADA ID: 1694BC5EAD59	Ramp Type: PerpDiag	Initial Pass/Fail: Fail	Overall Compliance: No
		Severity Score: 22.5

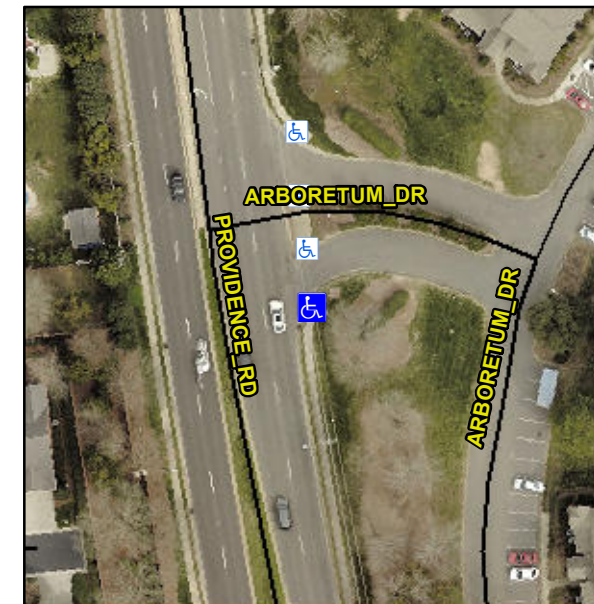
**R304.5.1, R304.2.2, R304.5.3**

Compliance	Description	Data	Compliance	Description	Data
N/A	Ramp Length (in)	71.0	No	Ramp Slope (%)	9.1
No	Ramp Width (in)	41.0	No	Ramp XSlope (%)	3.4
N/A	Flare Type LT	N/A	N/A	Flare Type RT	N/A
N/A	Flare Slope LT (%)	N/A	N/A	Flare Slope RT (%)	N/A
N/A	Flare Traversable LT?	N/A	N/A	Flare Traversable RT?	N/A
N/A	Landing Length (in)	N/A	N/A	DWS Provided?	N/A
N/A	Landing Width (in)	N/A	N/A	DWS Contrast?	N/A
N/A	Landing Slope (%)	N/A	N/A	DWS Length (in)	N/A
N/A	Landing X Slope (%)	N/A	N/A	DWS Full Width?	N/A
N/A	Landing Curb? (Y/N)	N/A	N/A	DWS Offset (in)	N/A
N/A	Shared Landing?	N/A			
N/A	Gutter Ponding?	N/A	N/A	Gutter Slope (%)	N/A
N/A	Gutter Lip Ht (in)	N/A	N/A	Gutter X Slope (%)	N/A
N/A	Painted X Walk1?	No	N/A	Painted X Walk2?	No
	X Walk 1 Direction	To N		X Walk 2 Direction	To W
N/A	X Walk 1 Width (in)	N/A	N/A	X Walk 2 Width (in)	N/A
	X Walk 1 Slope (%)	2.4		X Walk 2 Slope (%)	3.1
	X Walk 1 X Slope (%)	3.2		X Walk 2 X Slope (%)	2.5

N/A	Ramp inside XWalk1?	N/A	N/A	Ramp inside XWalk2?	N/A
	Road Slope (%)	1.9	N/A	Clear Space?	N/A
	Road X Slope (%)	4.7	N/A	Clear Space to XWalk (in)	N/A
N/A	Any Obstructions?	N/A	N/A	Storm Grate/Utility Hazard?	N/A
	Obstruction Type			Storm Grate/Utility Type	
		N/A			N/A
			Yes	Surface Condition? (G/P)	Good

**Remove & Replace Curb Ramp With Two New Directional Ramps or Equivalent.**
