# Access Compliance Report

## Public Rights-of-Way

### (Curb Ramps)

| Intersection ID: 19826 | Main Street: THERMAL_RD | Cross Street: PATIMBY_RD | Location: NE |

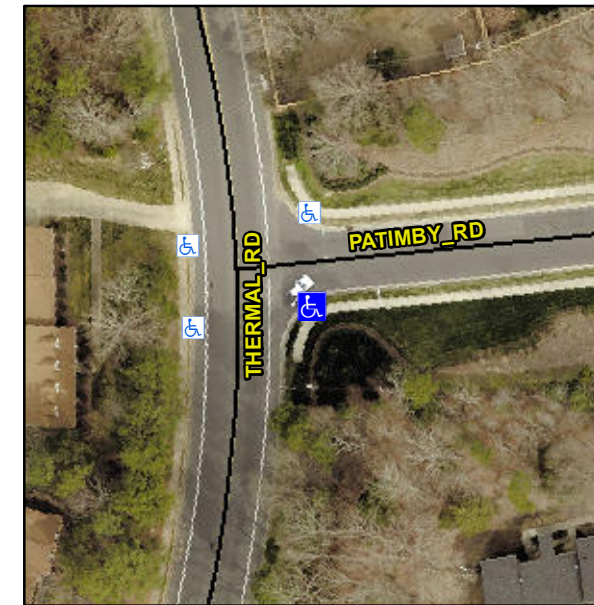
| ADA ID: 16ACB836FD3E | Ramp Type: PerpDiag | Initial Pass/Fail: Fail | Overall Compliance: No |
| | | Severity Score: 25 | |

**Not Found, R304.2.2, R304.5.3**

| Compliance | Description | Data | Compliance | Description | Data |
|---|---|---|---|---|---|
| N/A | Ramp Length (in) | 47.0 | No | Ramp Slope (%) | 10.8 |
| Yes | Ramp Width (in) | 48.0 | No | Ramp XSlope (%) | 6.2 |

**Remove & Replace Curb Ramp With Two New Directional Ramps or Equivalent.**

Total Cost: \$ 3200.00
