Access Compliance Report

Public Rights-of-Way

(Curb Ramps)

Intersection ID: 24473	Main Street: CAMERON_WOOD_DR	Cross Street: DEER SPRING_LN	Location: W
ADA ID: 16B015EEC4A3	Ramp Type: PerpDiag	Initial Pass/Fail: Fail	Overall Compliance: No
Severity Score: 33.75			
Codes/Mitigation Info/Possible Solution		Field Measurements/Component Compliance

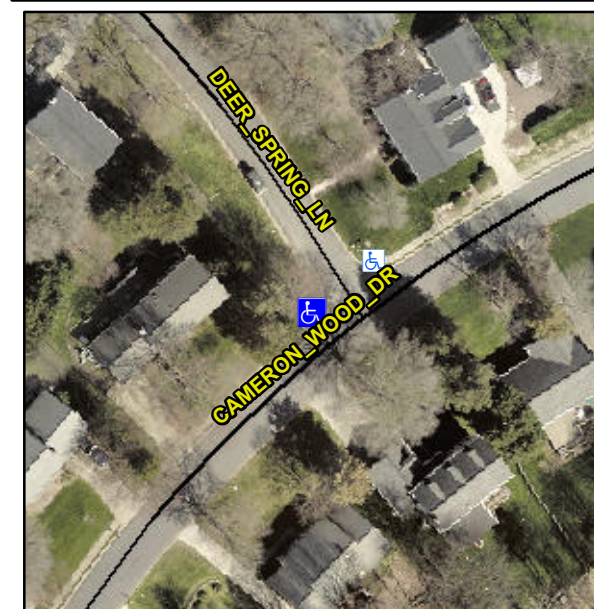
Not Found, R304.5.1, R304.2.2, R304.5.3

Compliance	Description	Data	Compliance	Description	Data
N/A	Ramp Length (in)	60.0	No	Ramp Slope (%)	9.3
No	Ramp Width (in)	39.0	No	Ramp XSlope (%)	6.0
N/A	Flare Type LT	N/A	N/A	Flare Type RT	N/A
N/A	Flare Slope LT (%)	N/A	N/A	Flare Slope RT (%)	N/A
N/A	Flare Traversable LT?	N/A	N/A	Flare Traversable RT?	N/A
N/A	Landing Length (in)	N/A	N/A	DWS Provided?	N/A
N/A	Landing Width (in)	N/A	N/A	DWS Contrast?	N/A
N/A	Landing Slope (%)	N/A	N/A	DWS Length (in)	N/A
N/A	Landing X Slope (%)	N/A	N/A	DWS Full Width?	N/A
N/A	Landing Curb? (Y/N)	N/A	N/A	DWS Offset (in)	N/A
N/A	Shared Landing?	N/A			
N/A	Gutter Ponding?	N/A	N/A	Gutter Slope (%)	N/A
N/A	Gutter Lip Ht (in)	N/A	N/A	Gutter X Slope (%)	N/A
N/A	Painted X Walk1?	No	N/A	Painted X Walk2?	No
	X Walk 1 Direction	To S		X Walk 2 Direction	To NE
N/A	X Walk 1 Width (in)	N/A	N/A	X Walk 2 Width (in)	N/A
	X Walk 1 Slope (%)	3.5		X Walk 2 Slope (%)	7.4
	X Walk 1 X Slope (%)	6.6		X Walk 2 X Slope (%)	2.5

N/A	Ramp inside XWalk1?	N/A	N/A	Ramp inside XWalk2?	N/A
	Road Slope (%)	3.5	N/A	Clear Space?	N/A
	Road X Slope (%)	5.8	N/A	Clear Space to XWalk (in)	N/A
N/A	Any Obstructions?	N/A	N/A	Storm Grate/Utility Hazard?	N/A
	Obstruction Type			Storm Grate/Utility Type	
		N/A			N/A
			Yes	Surface Condition? (G/P)	Good

Remove & Replace Curb Ramp With Two New Directional Ramps or Equivalent.
