# Access Compliance Report

## Public Rights-of-Way

### (Curb Ramps)

Intersection ID: 12435	Main Street: ALLEN_ST	Cross Street: PEGRAM_ST	Location: E
ADA ID: 16C3CAC291ED	Ramp Type: PerpDiag	Initial Pass/Fail: Fail	Overall Compliance: No
Severity Score: 31.25			
Codes/Mitigation Info/Possible Solution		Field Measurements/Component Compliance

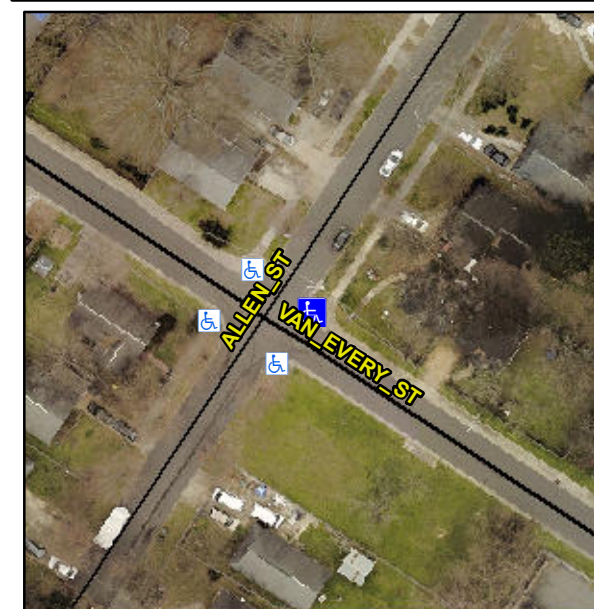
**Not Found, R304.5.1, R304.2.2, R304.5.3**

Compliance	Description	Data	Compliance	Description	Data
N/A	Ramp Length (in)	87.0	No	Ramp Slope (%)	8.8
No	Ramp Width (in)	33.0	No	Ramp XSlope (%)	2.3
N/A	Flare Type LT	N/A	N/A	Flare Type RT	N/A
N/A	Flare Slope LT (%)	N/A	N/A	Flare Slope RT (%)	N/A
N/A	Flare Traversable LT?	N/A	N/A	Flare Traversable RT?	N/A
N/A	Landing Length (in)	N/A	N/A	DWS Provided?	N/A
N/A	Landing Width (in)	N/A	N/A	DWS Contrast?	N/A
N/A	Landing Slope (%)	N/A	N/A	DWS Length (in)	N/A
N/A	Landing X Slope (%)	N/A	N/A	DWS Full Width?	N/A
N/A	Landing Curb? (Y/N)	N/A	N/A	DWS Offset (in)	N/A
N/A	Shared Landing?	N/A			
N/A	Gutter Ponding?	N/A	N/A	Gutter Slope (%)	N/A
N/A	Gutter Lip Ht (in)	N/A	N/A	Gutter X Slope (%)	N/A
N/A	Painted X Walk1?	No	N/A	Painted X Walk2?	No
	X Walk 1 Direction	To NW		X Walk 2 Direction	To SW
N/A	X Walk 1 Width (in)	N/A	N/A	X Walk 2 Width (in)	N/A
	X Walk 1 Slope (%)	5.9		X Walk 2 Slope (%)	0.6
	X Walk 1 X Slope (%)	3.1		X Walk 2 X Slope (%)	3.6

N/A	Ramp inside XWalk1?	N/A	N/A	Ramp inside XWalk2?	N/A
	Road Slope (%)	2.7	N/A	Clear Space?	N/A
	Road X Slope (%)	1.2	N/A	Clear Space to XWalk (in)	N/A
N/A	Any Obstructions?	N/A	N/A	Storm Grate/Utility Hazard?	N/A
	Obstruction Type			Storm Grate/Utility Type	
		N/A			N/A
			Yes	Surface Condition? (G/P)	Good

**Remove & Replace Curb Ramp With Two New Directional Ramps or Equivalent.**

Total Cost: \$ 3200.00
