# Access Compliance Report

## Public Rights-of-Way

### (Curb Ramps)

Intersection ID: 30248	Main Street: OLD_IRNSIDE_DR	Cross Street: WOLVERINE_CT	Location: NE
ADA ID: 16CF6D2581C9	Ramp Type: BlendTrans1	Initial Pass/Fail: Fail	Overall Compliance: No
Severity Score: 12.5			
Codes/Mitigation Info/Possible Solution		Field Measurements/Component Compliance

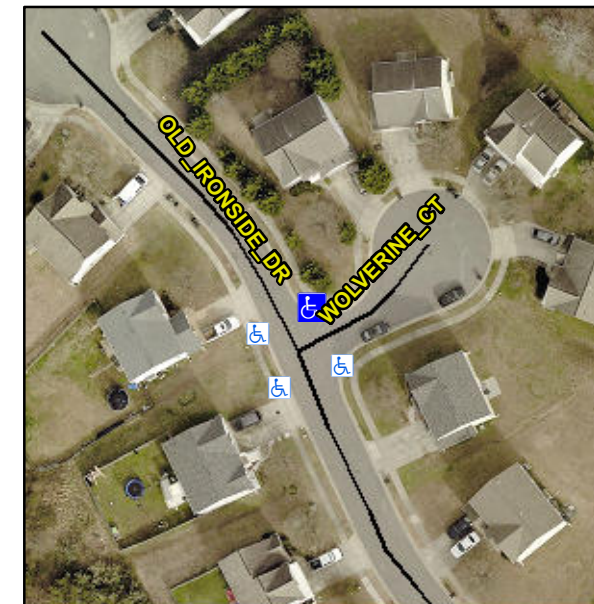
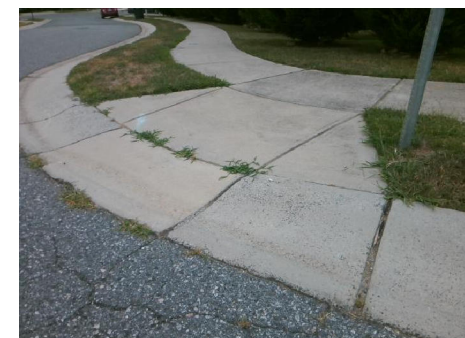
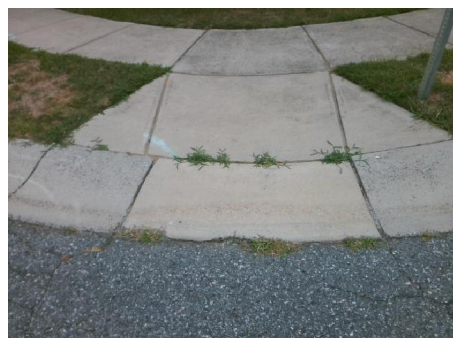
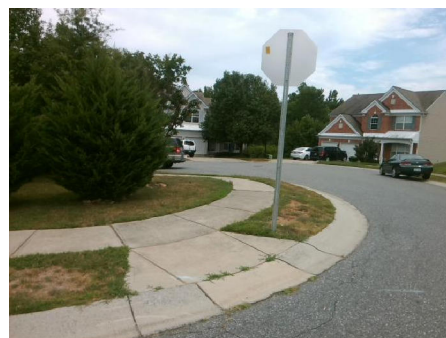
**CURB WIDTH 46.5**

**Not Found, R304.5.3**

Compliance	Description	Data	Compliance	Description	Data
N/A	Ramp Length (in)	48.0	Yes	BlendTrans Slope (%)	4.2
Yes	Ramp Width (in)	49.0	No	BlendTrans XSlope (%)	6.0
N/A	Flare Type LT	N/A	N/A	Flare Type RT	N/A
N/A	Flare Slope LT (%)	N/A	N/A	Flare Slope RT (%)	N/A
N/A	Flare Traversable LT?	N/A	N/A	Flare Traversable RT?	N/A
N/A	Landing Length (in)	N/A	N/A	DWS Provided?	N/A
N/A	Landing Width (in)	N/A	N/A	DWS Contrast?	N/A
N/A	Landing Slope (%)	N/A	N/A	DWS Length (in)	N/A
N/A	Landing X Slope (%)	N/A	N/A	DWS Full Width?	N/A
N/A	Landing Curb? (Y/N)	N/A	N/A	DWS Offset (in)	N/A
N/A	Shared Landing?	N/A			
N/A	Gutter Ponding?	N/A	N/A	Gutter Slope (%)	N/A
N/A	Gutter Lip Ht (in)	N/A	N/A	Gutter X Slope (%)	N/A
N/A	Painted X Walk1?	No	N/A	Painted X Walk2?	No
	X Walk 1 Direction	To SW		X Walk 2 Direction	To SE
	X Walk 1 Width (in)	N/A		X Walk 2 Width (in)	N/A
	X Walk 1 Slope (%)	1.7		X Walk 2 Slope (%)	3.4
	X Walk 1 X Slope (%)	7.5		X Walk 2 X Slope (%)	1.9

N/A	Ramp inside XWalk1?	N/A	N/A	Ramp inside XWalk2?	N/A
	Road Slope (%)	2.9		Clear Space?	N/A
	Road X Slope (%)	5.5	N/A	Clear Space to XWalk (in)	N/A
N/A	Any Obstructions?	N/A	N/A	Storm Grate/Utility Hazard?	N/A
	Obstruction Type			Storm Grate/Utility Type	
		N/A			N/A
			Yes	Surface Condition? (G/P)	Good
			No	Curb Slope (%)	9.3

**Remove & Replace Curb Ramp With Two New Directional Ramps or Equivalent.**
