## Access Compliance Report Public Rights-of-Way (Curb Ramps)

Intersection ID: 13094 Main Street: WINNIFRED\_ST Cross Street: WILCOX\_ST Location: SE

ADA ID: 16D80F9DB897 Ramp Type: PerpDiag Initial Pass/Fail: Fail Overall Compliance: No Severity Score: 25

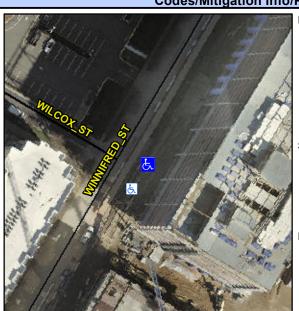
| Field Measurements/Component Compilance | | | | | |
|---|---|---|---|---|---|
| Yes | Ramp Width (in) | 48.0 | No | Ramp XSlope (%) | 12.5 |

Remove & Replace Curb Ramp With Two New Directional Ramps or Equivalent.

R304.5.3
