# Access Compliance Report

## Public Rights-of-Way

### (Curb Ramps)

Intersection ID: 53096	Main Street: ROBERT_IRWIN_DR	Cross Street: DIXIE_RIVER_RD	Location: E
ADA ID: 16E50DD2DD73	Ramp Type: PerpDiag	Initial Pass/Fail: Fail	Overall Compliance: No
		Severity Score: 8.75

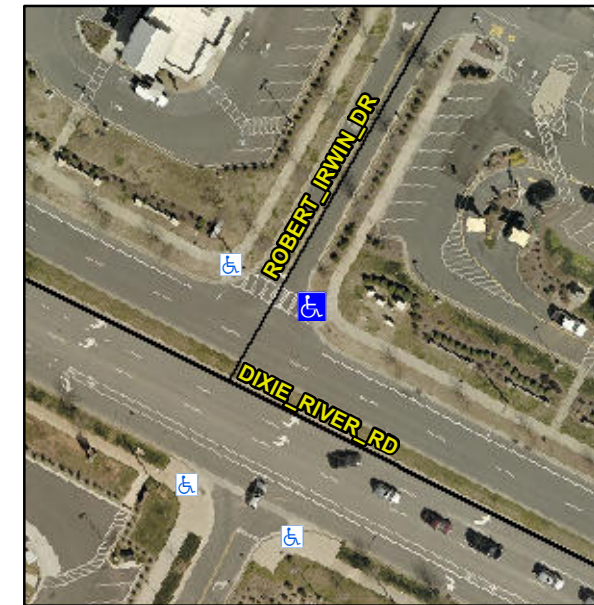
**Not Found, R304.5.1**

Compliance	Description	Data	Compliance	Description	Data
N/A	Ramp Length (in)	95.0	Yes	Ramp Slope (%)	6.3
No	Ramp Width (in)	44.5	Yes	Ramp XSlope (%)	0.4
N/A	Flare Type LT	N/A	N/A	Flare Type RT	N/A
N/A	Flare Slope LT (%)	N/A	N/A	Flare Slope RT (%)	N/A
N/A	Flare Traversable LT?	N/A	N/A	Flare Traversable RT?	N/A
N/A	Landing Length (in)	N/A	N/A	DWS Provided?	N/A
N/A	Landing Width (in)	N/A	N/A	DWS Contrast?	N/A
N/A	Landing Slope (%)	N/A	N/A	DWS Length (in)	N/A
N/A	Landing X Slope (%)	N/A	N/A	DWS Full Width?	N/A
N/A	Landing Curb? (Y/N)	N/A	N/A	DWS Offset (in)	N/A
N/A	Shared Landing?	N/A			
N/A	Gutter Ponding?	N/A	N/A	Gutter Slope (%)	N/A
N/A	Gutter Lip Ht (in)	N/A	N/A	Gutter X Slope (%)	N/A
N/A	Painted X Walk1?	Yes	N/A	Painted X Walk2?	No
	X Walk 1 Direction	To NW		X Walk 2 Direction	To SW
N/A	X Walk 1 Width (in)	110.0	N/A	X Walk 2 Width (in)	N/A
	X Walk 1 Slope (%)	2.5		X Walk 2 Slope (%)	1.3
	X Walk 1 X Slope (%)	2.8		X Walk 2 X Slope (%)	2.1

N/A	Ramp inside XWalk1?	Yes	N/A	Ramp inside XWalk2?	N/A
	Road Slope (%)	0.1	N/A	Clear Space?	N/A
	Road X Slope (%)	5.2	N/A	Clear Space to XWalk (in)	N/A
N/A	Any Obstructions?	N/A	N/A	Storm Grate/Utility Hazard?	N/A
	Obstruction Type			Storm Grate/Utility Type	
		N/A			N/A
			Yes	Surface Condition? (G/P)	Good

**Remove & Replace Curb Ramp With Two New Directional Ramps or Equivalent.**
