# Access Compliance Report

## Public Rights-of-Way

### (Curb Ramps)

Intersection ID: 48454	Main Street: RED_RUST_LN	Cross Street: GOLF_LINKS_DR	Location: NW
ADA ID: 16F1CAE620E5	Ramp Type: Perp	Initial Pass/Fail: Fail	Overall Compliance: No
		Severity Score: 1.25

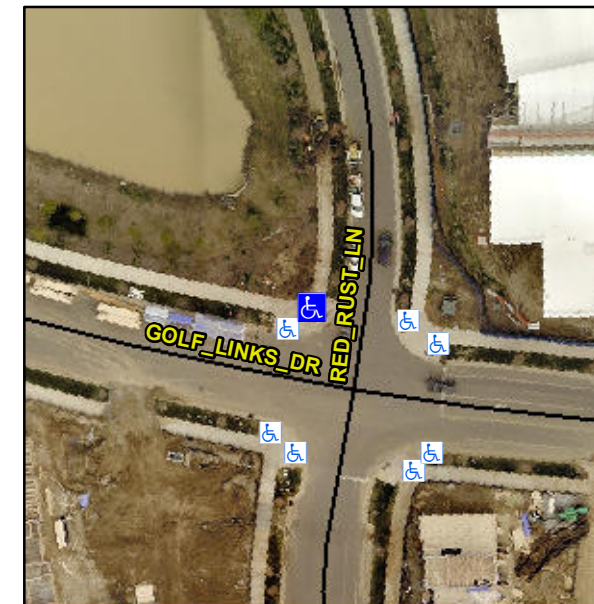
**Not Found, R304.5.3**

Compliance	Description	Data	Compliance	Description	Data
N/A	Ramp Length (in)	93.0	Yes	Ramp Slope (%)	6.8
Yes	Ramp Width (in)	60.0	No	Ramp XSlope (%)	2.6
N/A	Flare Type LT	N/A	N/A	Flare Type RT	N/A
N/A	Flare Slope LT (%)	N/A	N/A	Flare Slope RT (%)	N/A
N/A	Flare Traversable LT?	N/A	N/A	Flare Traversable RT?	N/A
N/A	Landing Length (in)	N/A	N/A	DWS Provided?	N/A
N/A	Landing Width (in)	N/A	N/A	DWS Contrast?	N/A
N/A	Landing Slope (%)	N/A	N/A	DWS Length (in)	N/A
N/A	Landing X Slope (%)	N/A	N/A	DWS Full Width?	N/A
N/A	Landing Curb? (Y/N)	N/A	N/A	DWS Offset (in)	N/A
N/A	Shared Landing?	N/A			
N/A	Gutter Ponding?	N/A	N/A	Gutter Slope (%)	N/A
N/A	Gutter Lip Ht (in)	N/A	N/A	Gutter X Slope (%)	N/A
N/A	Painted X Walk1?	No	N/A	Painted X Walk2?	N/A
	X Walk 1 Direction	To E		X Walk 2 Direction	N/A
N/A	X Walk 1 Width (in)	N/A	N/A	X Walk 2 Width (in)	N/A
	X Walk 1 Slope (%)	5.5		X Walk 2 Slope (%)	N/A
	X Walk 1 X Slope (%)	4.9		X Walk 2 X Slope (%)	N/A

**Remove & Replace Entire Ramp.**

Total Cost: \$ 1850.00
