Access Compliance Report

Public Rights-of-Way

(Curb Ramps)

| Intersection ID: 15274 | Main Street: GLEN_LAKE_DR | Cross Street: CASCADE_POINTE_BV | Location: NE |

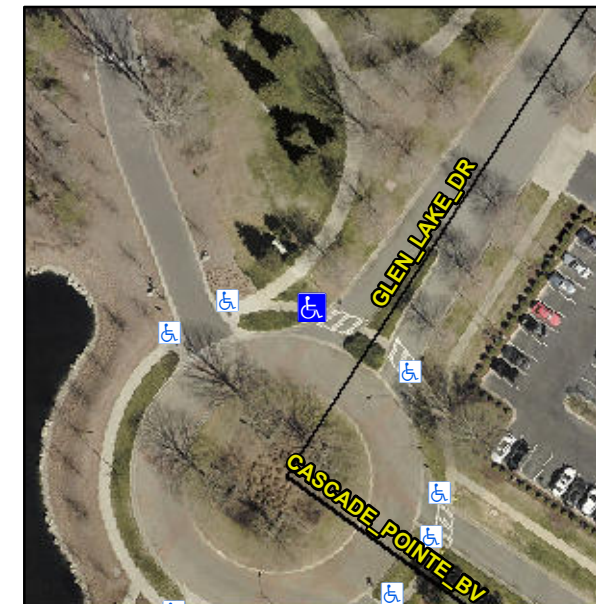
| ADA ID: 16FDAD273682 | Ramp Type: Perp | Initial Pass/Fail: Fail | Overall Compliance: No |

Not Found, R304.2.2

| Compliance | Description | Data | Compliance | Description | Data |
|---|---|---|---|---|---|
| N/A | Ramp Length (in) | 129.0 | No | Ramp Slope (%) | 9.7 |

Remove & Replace Entire Ramp.
