Access Compliance Report

Public Rights-of-Way (Curb Ramps)

Intersection ID: 10020394	Main Street: BALLANTYNE_CROSSING_AV	Cross Street: N/A	Location: NW
ADA ID: 170BECED18FD	Ramp Type: Directional1	Initial Pass/Fail: Fail	Overall Compliance: No
Severity Score: 1.25			
Codes/Mitigation Info/Possible Solution		Field Measurements/Component Compliance

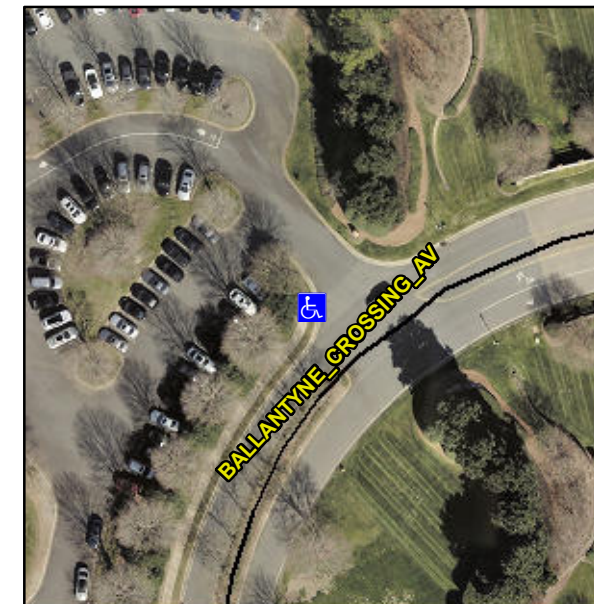
Compliance	Description	Data	Compliance	Description	Data
N/A	Ramp Length (in)	42.0	N/A	Grade Break?	N/A
Yes	Ramp Width (in)	59.0	N/A	Grade Break Slope (%)	0.0
Yes	Ramp Slope (%)	4.3	N/A	Grade Break XSlope (%)	0.0
No	Ramp XSlope (%)	3.2			
N/A	Flare Type LT	N/A	N/A	Flare Type RT	N/A
N/A	Flare Slope LT (%)	N/A	N/A	Flare Slope RT (%)	0.0
N/A	Flare Traversable LT?	N/A	N/A	Flare Traversable RT?	N/A
N/A	Landing Length (in)	0.0	N/A	DWS Provided?	N/A
N/A	Landing Width (in)	0.0	N/A	DWS Contrast?	N/A
N/A	Landing Slope (%)	0.0	N/A	DWS Length (in)	N/A
N/A	Landing X Slope (%)	0.0	N/A	DWS Full Width?	N/A
N/A	Landing Curb? (Y/N)	N/A	N/A	DWS Offset LT (in)	N/A
N/A	Shared Landing?	N/A	N/A	DWS Offset RT (in)	N/A
N/A	Gutter Ponding?	0.0	N/A	Gutter Slope (%)	N/A
N/A	Gutter Lip Ht (in)	0.0	N/A	Gutter X Slope (%)	N/A
N/A	Painted X Walk1?	No		Road Slope (%)	0.0
	X Walk 1 Direction	To NE		Road X Slope (%)	6.1
	X Walk 1 Width (in)	N/A		Clear Space?	N/A

X Walk 1 Slope (%)	0.0	N/A	Clear Space to XWalk (in)	N/A
	X Walk 1 X Slope (%)	6.1	N/A	Storm Grate/Utility Hazard?	N/A
N/A	Ramp inside XWalk1?	N/A		Storm Grate/Utility Type	
N/A	Any Obstructions?	N/A			N/A
	Obstruction Type		Yes	Surface Condition? (G/P)	Good
			N/A	Curb Slope (%)	14.5

Possible Solutions:

Remove & Replace Entire Ramp.

R304.5.3

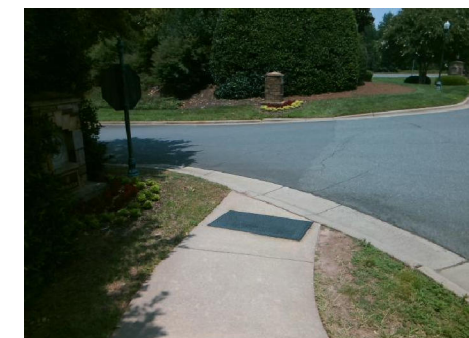
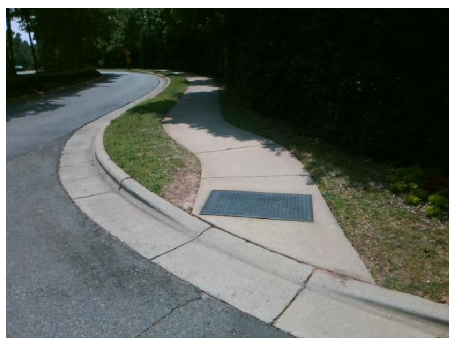
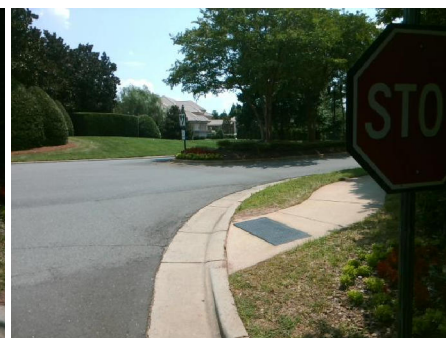
Street 1 Name	ENTRANCE
Stop Condition-Street 1	StopSign
Street 2 Name	N/A
Stop Condition-Street 2	N/A
