# Access Compliance Report

## Public Rights-of-Way

### (Curb Ramps)

| Intersection ID: 32115 | Main Street: COLE_MILL_RD | Cross Street: GALT_Y_LN | Location: S |

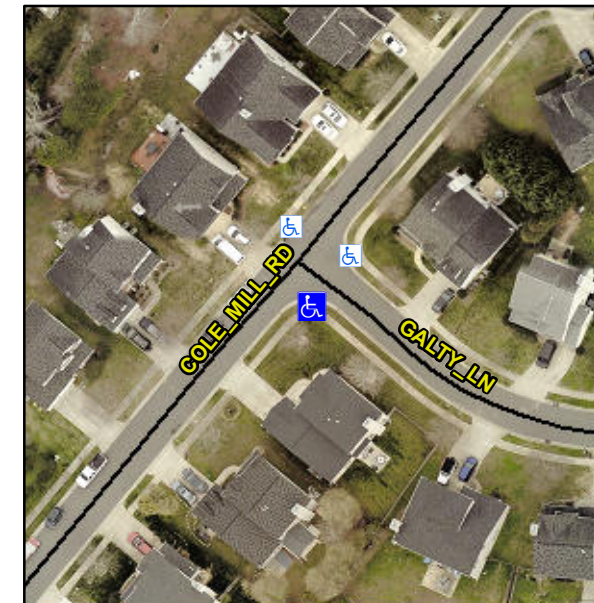
#### Field Measurements/Component Compliance

**Not Found, R304.5.3, R304.2.1, R305, R304.5.4**

| Compliance | Description | Data | Compliance | Description | Data |
|---|---|---|---|---|---|
| Yes | Ramp Width (in) | 50.0 | No | BlendTrans XSlope (%) | 3.3 |
| No | Landing Length (in) | 46.5 | No | DWS Provided? | No |
| No | Landing X Slope (%) | 3.1 | N/A | DWS Full Width? | No |
| Yes | Gutter Ponding? | No | No | Gutter Slope (%) | 8.9 |
| | | | No | Curb Slope (%) | 11.7 |

**Remove & Replace Curb Ramp With Two New Directional Ramps or Equivalent. Remove & Replace Gutter.**

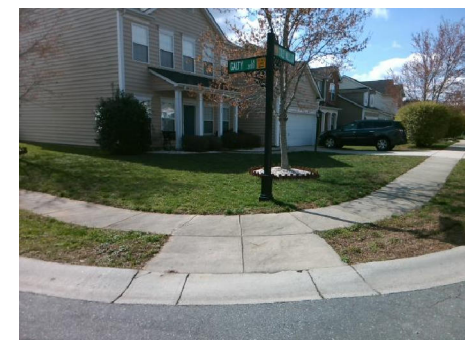
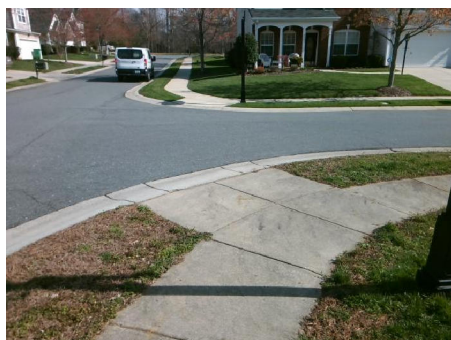
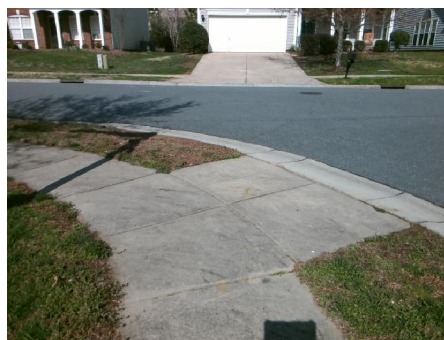
Street 1 Name GALTY LN  
 Stop Condition-Street 1 StopSign  
 Street 2 Name COLE MILL RD  
 Stop Condition-Street 2 None
