Access Compliance Report

Public Rights-of-Way

(Curb Ramps)

Intersection ID: 31585	Main Street: NAPTON_CT	Cross Street: PATTONSBURG_DR	Location: NW
ADA ID: 17175DA8DF65	Ramp Type: PerpDiag	Initial Pass/Fail: Fail	Overall Compliance: No
Severity Score: 8.75			
Codes/Mitigation Info/Possible Solution		Field Measurements/Component Compliance

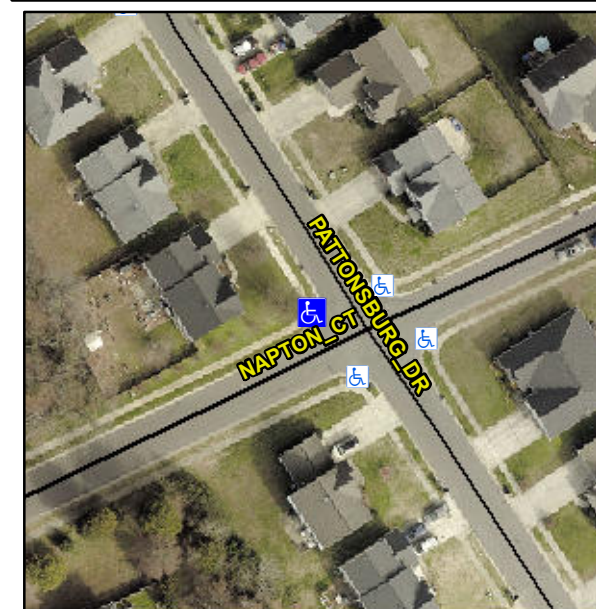
Not Found, R304.5.1

Compliance	Description	Data	Compliance	Description	Data
N/A	Ramp Length (in)	49.0	Yes	Ramp Slope (%)	6.5
No	Ramp Width (in)	39.0	Yes	Ramp XSlope (%)	0.3
N/A	Flare Type LT	N/A	N/A	Flare Type RT	N/A
N/A	Flare Slope LT (%)	N/A	N/A	Flare Slope RT (%)	N/A
N/A	Flare Traversable LT?	N/A	N/A	Flare Traversable RT?	N/A
N/A	Landing Length (in)	N/A	N/A	DWS Provided?	N/A
N/A	Landing Width (in)	N/A	N/A	DWS Contrast?	N/A
N/A	Landing Slope (%)	N/A	N/A	DWS Length (in)	N/A
N/A	Landing X Slope (%)	N/A	N/A	DWS Full Width?	N/A
N/A	Landing Curb? (Y/N)	N/A	N/A	DWS Offset (in)	N/A
N/A	Shared Landing?	N/A			
N/A	Gutter Ponding?	N/A	N/A	Gutter Slope (%)	N/A
N/A	Gutter Lip Ht (in)	1.0	N/A	Gutter X Slope (%)	N/A
N/A	Painted X Walk1?	No	N/A	Painted X Walk2?	No
	X Walk 1 Direction	To S		X Walk 2 Direction	To E
N/A	X Walk 1 Width (in)	N/A	N/A	X Walk 2 Width (in)	N/A
	X Walk 1 Slope (%)	0.1		X Walk 2 Slope (%)	3.4
	X Walk 1 X Slope (%)	0.0		X Walk 2 X Slope (%)	0.5

N/A	Ramp inside XWalk1?	N/A	N/A	Ramp inside XWalk2?	N/A
	Road Slope (%)	0.6	N/A	Clear Space?	N/A
	Road X Slope (%)	2.2	N/A	Clear Space to XWalk (in)	N/A
N/A	Any Obstructions?	N/A	N/A	Storm Grate/Utility Hazard?	N/A
	Obstruction Type			Storm Grate/Utility Type	
		N/A			N/A
		Yes		Surface Condition? (G/P)	Good

Remove & Replace Curb Ramp With Two New Directional Ramps or Equivalent.

Total Cost: \$ 3200.00
