Access Compliance Report

Public Rights-of-Way

(Curb Ramps)

| Intersection ID: 14378 | Main Street: E_WORTHINGTON_AV | Cross Street: EUCLID_AV | Location: E |

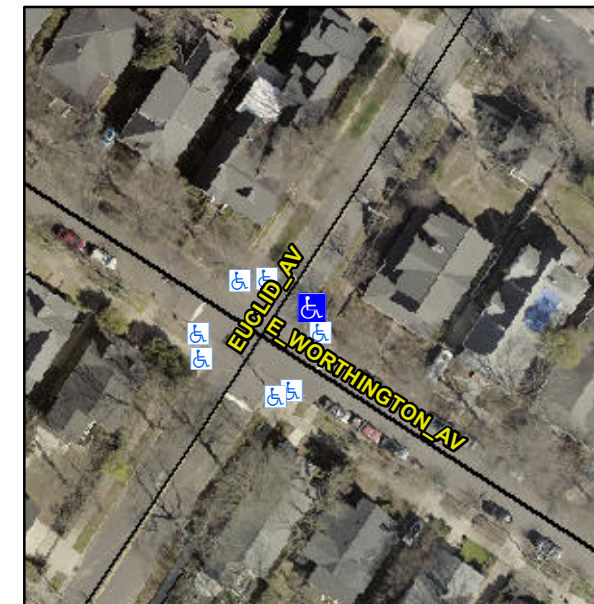
| ADA ID: 1739AB19B6C1 | Ramp Type: Perp | Initial Pass/Fail: Fail | Overall Compliance: No |
| | | Severity Score: 8.75 | |

R304.5.1

| Compliance | Description | Data | Compliance | Description | Data |
|---|---|---|---|---|---|
| No | Ramp Width (in) | 41.0 | Yes | Ramp XSlope (%) | 0.8 |

Possible Solutions:

Remove & Replace Entire Ramp.
