# Access Compliance Report

## Public Rights-of-Way

### (Curb Ramps)

Intersection ID: 47850	Main Street: LAGO_VISTA_CT	Cross Street: SERAPE_RD	Location: NE
ADA ID: 1745401E1BD3	Ramp Type: Perp	Initial Pass/Fail: Fail	Overall Compliance: No
Severity Score: 21.25			
Codes/Mitigation Info/Possible Solution		Field Measurements/Component Compliance

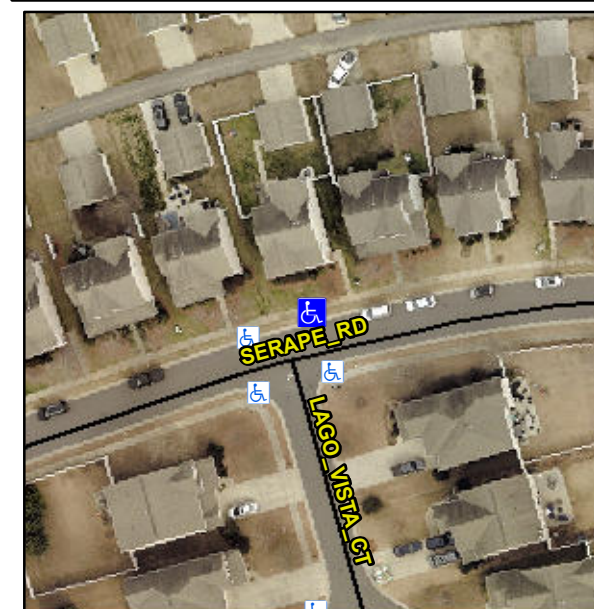
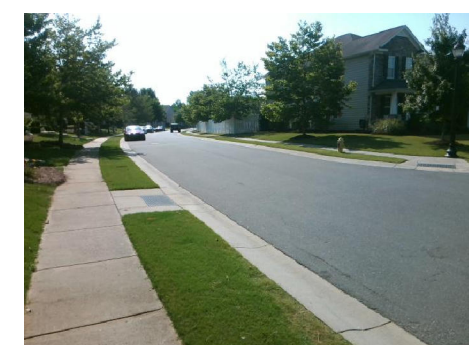
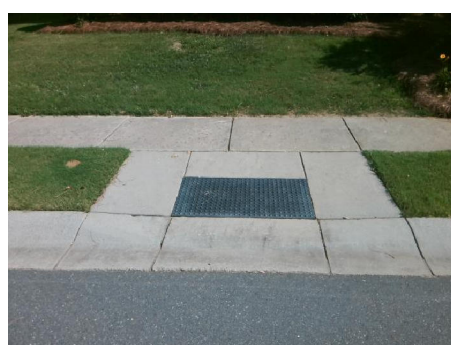
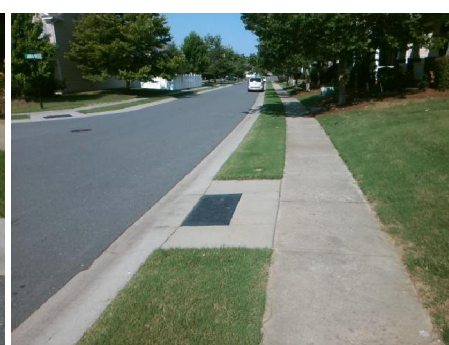
Compliance	Description	Data	Compliance	Description	Data
N/A	Ramp Length (in)	47.0	No	Ramp Slope (%)	9.1
No	Ramp Width (in)	47.0	Yes	Ramp XSlope (%)	1.9
N/A	Flare Type LT	N/A	N/A	Flare Type RT	N/A
N/A	Flare Slope LT (%)	N/A	N/A	Flare Slope RT (%)	N/A
N/A	Flare Traversable LT?	N/A	N/A	Flare Traversable RT?	N/A
N/A	Landing Length (in)	N/A	N/A	DWS Provided?	N/A
N/A	Landing Width (in)	N/A	N/A	DWS Contrast?	N/A
N/A	Landing Slope (%)	N/A	N/A	DWS Length (in)	N/A
N/A	Landing X Slope (%)	N/A	N/A	DWS Full Width?	N/A
N/A	Landing Curb? (Y/N)	N/A	N/A	DWS Offset (in)	N/A
N/A	Shared Landing?	N/A			
N/A	Gutter Ponding?	N/A	N/A	Gutter Slope (%)	N/A
N/A	Gutter Lip Ht (in)	N/A	N/A	Gutter X Slope (%)	N/A
N/A	Painted X Walk1?	No	N/A	Painted X Walk2?	N/A
	X Walk 1 Direction	To S		X Walk 2 Direction	N/A
N/A	X Walk 1 Width (in)	N/A	N/A	X Walk 2 Width (in)	N/A
	X Walk 1 Slope (%)	2.9		X Walk 2 Slope (%)	N/A
	X Walk 1 X Slope (%)	0.9		X Walk 2 X Slope (%)	N/A

N/A	Ramp inside XWalk1?	N/A	N/A	Ramp inside XWalk2?	N/A
	Road Slope (%)	N/A	N/A	Clear Space?	N/A
	Road X Slope (%)	N/A	N/A	Clear Space to XWalk (in)	N/A
N/A	Any Obstructions?	N/A	N/A	Storm Grate/Utility Hazard?	N/A
	Obstruction Type			Storm Grate/Utility Type	
		N/A			N/A
			Yes	Surface Condition? (G/P)	Good

**Remove & Replace Entire Ramp.**

**R304.5.1, R304.2.2**

Total Cost: \$ 1850.00
