Access Compliance Report

Public Rights-of-Way

(Curb Ramps)

| Intersection ID: 3015 | Main Street: FOX_TROT_DR | Cross Street: GLENSTONE_CT | Location: SE |

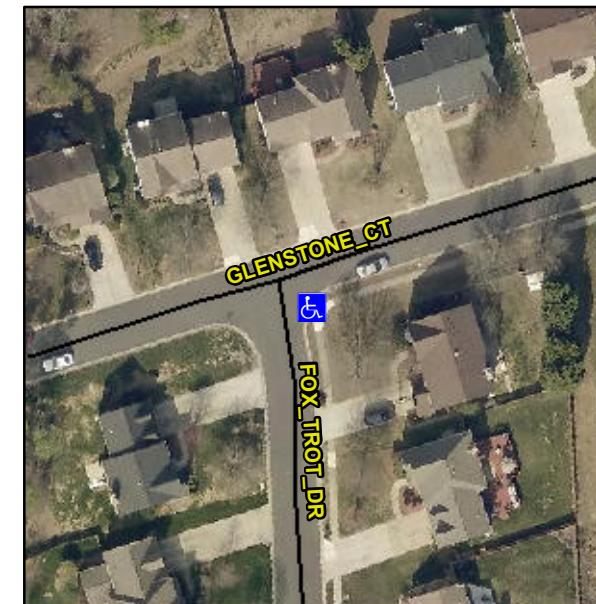
Not Found, R305.2

| Compliance | Description | Data | Compliance | Description | Data |
|---|---|---|---|---|---|
| N/A | Landing Curb? (Y/N) | No | No | DWS Offset (in) | 2.3 |

Remove & Replace Entire Ramp.

Total Cost: \$ 1850.00

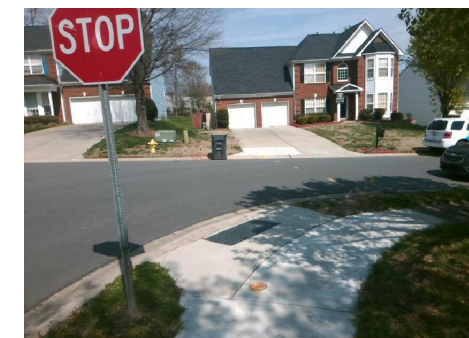
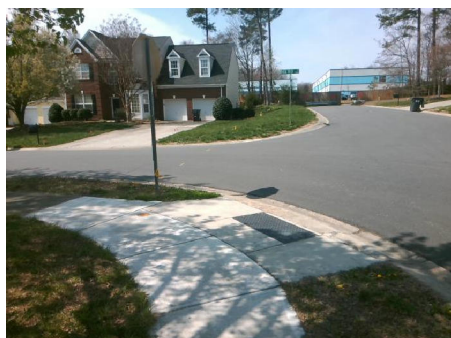
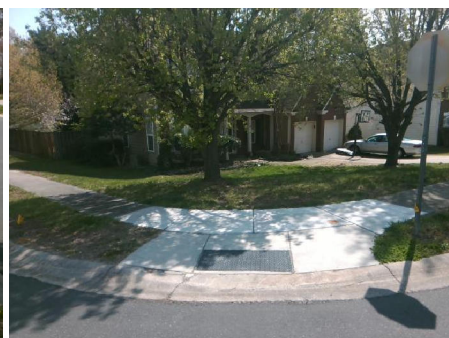
| Compliance | Description | Data | Compliance | Description | Data |
|---|---|---|---|---|---|
| | | | Yes | Surface Condition? (G/P) | Good |
