Access Compliance Report

Public Rights-of-Way

(Curb Ramps)

Intersection ID: 18269	Main Street: MCLAUGHLIN_DR	Cross Street: PINAFORE_DR	Location: SE
ADA ID: 175CD5818A99	Ramp Type: PerpDiag	Initial Pass/Fail: Fail	Overall Compliance: No
		Severity Score: 12.5

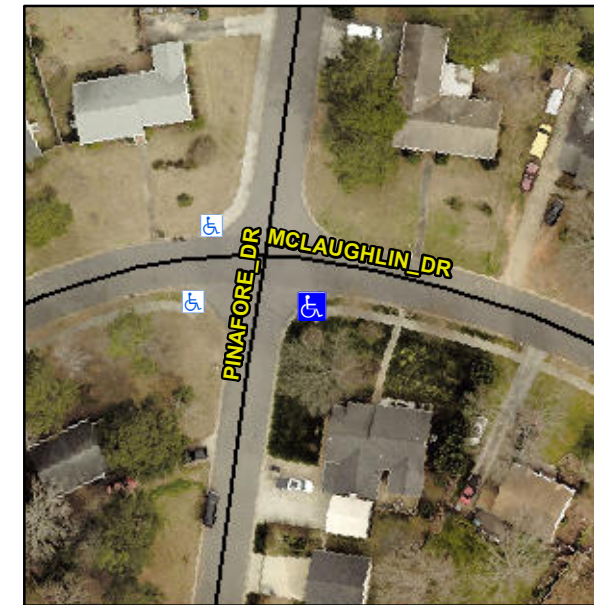
Compliance	Description	Data	Compliance	Description	Data
N/A	Ramp Length (in)	108.0	No	Ramp Slope (%)	8.6
Yes	Ramp Width (in)	48.0	Yes	Ramp XSlope (%)	1.3
N/A	Flare Type LT	N/A	N/A	Flare Type RT	N/A
N/A	Flare Slope LT (%)	N/A	N/A	Flare Slope RT (%)	N/A
N/A	Flare Traversable LT?	N/A	N/A	Flare Traversable RT?	N/A
N/A	Landing Length (in)	N/A	N/A	DWS Provided?	N/A
N/A	Landing Width (in)	N/A	N/A	DWS Contrast?	N/A
N/A	Landing Slope (%)	N/A	N/A	DWS Length (in)	N/A
N/A	Landing X Slope (%)	N/A	N/A	DWS Full Width?	N/A
N/A	Landing Curb? (Y/N)	N/A	N/A	DWS Offset (in)	N/A
N/A	Shared Landing?	N/A			
N/A	Gutter Ponding?	N/A	N/A	Gutter Slope (%)	N/A
N/A	Gutter Lip Ht (in)	N/A	N/A	Gutter X Slope (%)	N/A
N/A	Painted X Walk1?	No	N/A	Painted X Walk2?	No
	X Walk 1 Direction	To N		X Walk 2 Direction	To W
N/A	X Walk 1 Width (in)	N/A	N/A	X Walk 2 Width (in)	N/A
	X Walk 1 Slope (%)	6.9		X Walk 2 Slope (%)	6.2
	X Walk 1 X Slope (%)	6.3		X Walk 2 X Slope (%)	7.5

N/A	Ramp inside XWalk1?	N/A	N/A	Ramp inside XWalk2?	N/A
	Road Slope (%)	1.2	N/A	Clear Space?	N/A
	Road X Slope (%)	8.0	N/A	Clear Space to XWalk (in)	N/A
N/A	Any Obstructions?	N/A	N/A	Storm Grate/Utility Hazard?	N/A
	Obstruction Type			Storm Grate/Utility Type	
		N/A			N/A
			Yes	Surface Condition? (G/P)	Good

Possible Solutions:

Remove & Replace Curb Ramp With Two New Directional Ramps or Equivalent.

R304.2.2

Total Cost: \$ 3200.00
