# Access Compliance Report

## Public Rights-of-Way

### (Curb Ramps)

Intersection ID: 18538	Main Street: SENECA_PL	Cross Street: SOUTH_BV	Location: SE
ADA ID: 1764AA459CFD	Ramp Type: Perp	Initial Pass/Fail: Fail	Overall Compliance: No
Severity Score: 13.75			
Codes/Mitigation Info/Possible Solution		Field Measurements/Component Compliance

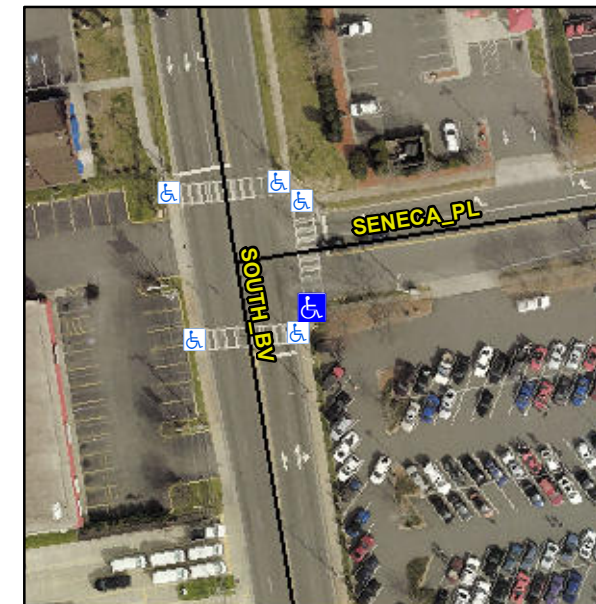
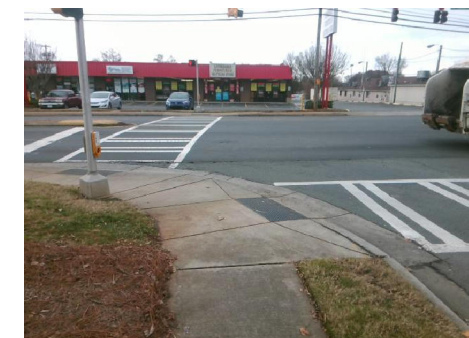
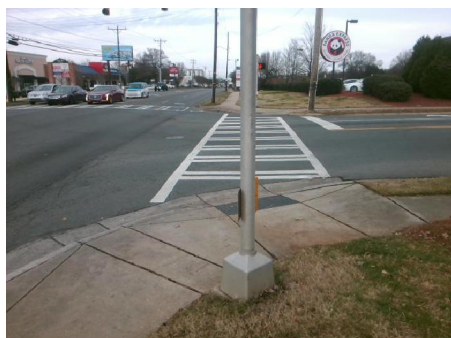
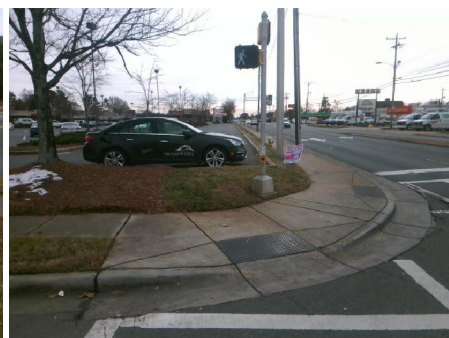
**Not Found, R304.2.2, R304.5.3**

Compliance	Description	Data	Compliance	Description	Data
N/A	Ramp Length (in)	84.0	No	Ramp Slope (%)	10.1
Yes	Ramp Width (in)	48.0	No	Ramp XSlope (%)	3.0
N/A	Flare Type LT	N/A	N/A	Flare Type RT	N/A
N/A	Flare Slope LT (%)	N/A	N/A	Flare Slope RT (%)	N/A
N/A	Flare Traversable LT?	N/A	N/A	Flare Traversable RT?	N/A
N/A	Landing Length (in)	N/A	N/A	DWS Provided?	N/A
N/A	Landing Width (in)	N/A	N/A	DWS Contrast?	N/A
N/A	Landing Slope (%)	N/A	N/A	DWS Length (in)	N/A
N/A	Landing X Slope (%)	N/A	N/A	DWS Full Width?	N/A
N/A	Landing Curb? (Y/N)	N/A	N/A	DWS Offset (in)	N/A
N/A	Shared Landing?	N/A			
N/A	Gutter Ponding?	N/A	N/A	Gutter Slope (%)	N/A
N/A	Gutter Lip Ht (in)	N/A	N/A	Gutter X Slope (%)	N/A
N/A	Painted X Walk1?	Yes	N/A	Painted X Walk2?	N/A
	X Walk 1 Direction	To N		X Walk 2 Direction	N/A
N/A	X Walk 1 Width (in)	114.0	N/A	X Walk 2 Width (in)	N/A
	X Walk 1 Slope (%)	2.9		X Walk 2 Slope (%)	N/A
	X Walk 1 X Slope (%)	2.2		X Walk 2 X Slope (%)	N/A

N/A	Ramp inside XWalk1?	Yes	N/A	Ramp inside XWalk2?	N/A
	Road Slope (%)	N/A	N/A	Clear Space?	N/A
	Road X Slope (%)	N/A	N/A	Clear Space to XWalk (in)	N/A
N/A	Any Obstructions?	N/A	N/A	Storm Grate/Utility Hazard?	N/A
	Obstruction Type			Storm Grate/Utility Type	
		N/A			N/A
		Yes		Surface Condition? (G/P)	Good

**Remove & Replace Entire Ramp.**
