Intersection ID: 18973	Main Street: ARBOR_WY	Cross Street: PELHAM_LN	Location:	NE
ADA ID: 17688CBCA985	Ramp Type: PerpDiag	Initial Pass/Fail: Fail	Overall Compliance: No	Severity Score: 33.75

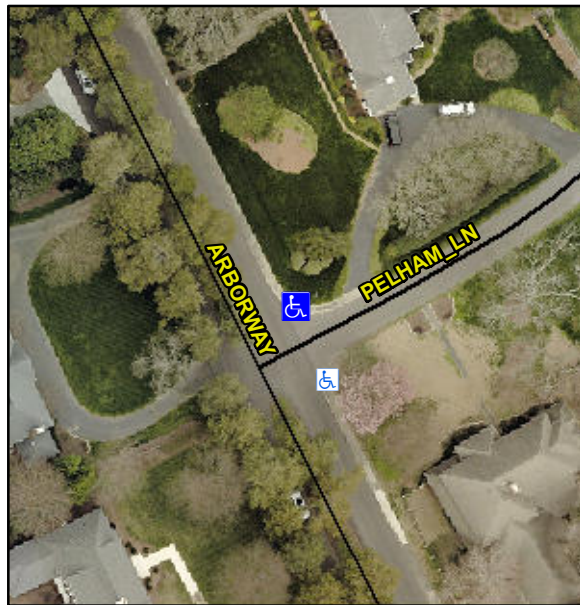
**Not Found, R304.5.1, R304.2.2**

Compliance	Description	Data	Compliance	Description	Data
N/A	Ramp Length (in)	38.0	No	Ramp Slope (%)	14.0
No	Ramp Width (in)	38.0	Yes	Ramp XSlope (%)	1.8
N/A	Flare Type LT	N/A	N/A	Flare Type RT	N/A
N/A	Flare Slope LT (%)	N/A	N/A	Flare Slope RT (%)	N/A
N/A	Flare Traversable LT?	N/A	N/A	Flare Traversable RT?	N/A
N/A	Landing Length (in)	N/A	N/A	DWS Provided?	N/A
N/A	Landing Width (in)	N/A	N/A	DWS Contrast?	N/A
N/A	Landing Slope (%)	N/A	N/A	DWS Length (in)	N/A
N/A	Landing X Slope (%)	N/A	N/A	DWS Full Width?	N/A
N/A	Landing Curb? (Y/N)	N/A	N/A	DWS Offset (in)	N/A
N/A	Shared Landing?	N/A			
N/A	Gutter Ponding?	N/A	N/A	Gutter Slope (%)	N/A
N/A	Gutter Lip Ht (in)	N/A	N/A	Gutter X Slope (%)	N/A
N/A	Painted X Walk1?	No	N/A	Painted X Walk2?	No
	X Walk 1 Direction	To SW		X Walk 2 Direction	To SE
N/A	X Walk 1 Width (in)	N/A	N/A	X Walk 2 Width (in)	N/A
	X Walk 1 Slope (%)	5.9		X Walk 2 Slope (%)	1.2
	X Walk 1 X Slope (%)	1.7		X Walk 2 X Slope (%)	4.7

N/A	Ramp inside XWalk1?	N/A	N/A	Ramp inside XWalk2?	N/A
	Road Slope (%)	3.6	N/A	Clear Space?	N/A
	Road X Slope (%)	3.8	N/A	Clear Space to XWalk (in)	N/A
N/A	Any Obstructions?	N/A	N/A	Storm Grate/Utility Hazard?	N/A
	Obstruction Type			Storm Grate/Utility Type	
		N/A			N/A
			Yes	Surface Condition? (G/P)	Good

**Remove & Replace Curb Ramp With Two New Directional Ramps or Equivalent.**

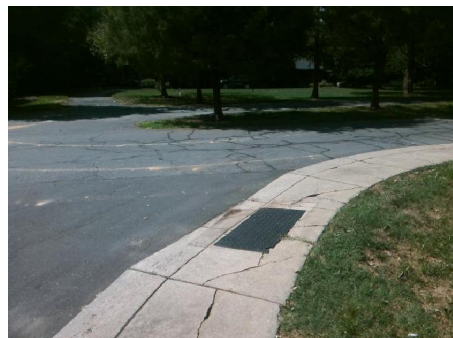
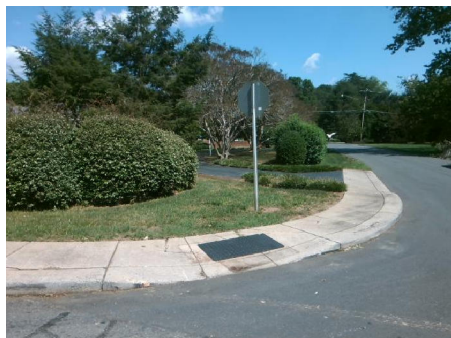
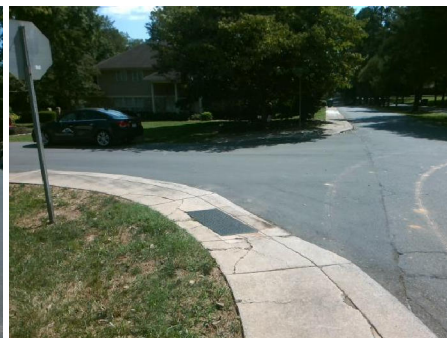
Street 1 Name	ARBOR WY
Stop Condition-Street 2	None
Street 2 Name	PELHAM LN
Stop Condition-Street 1	StopSign
