Access Compliance Report

Public Rights-of-Way

(Curb Ramps)

Intersection ID: 16077	Main Street: ELLENWOOD_PL	Cross Street: YORKSHIRE_DR	Location: NW
ADA ID: 17729E11EC7F	Ramp Type: PerpDiag	Initial Pass/Fail: Fail	Overall Compliance: No
Severity Score: 12.5			
Codes/Mitigation Info/Possible Solution		Field Measurements/Component Compliance

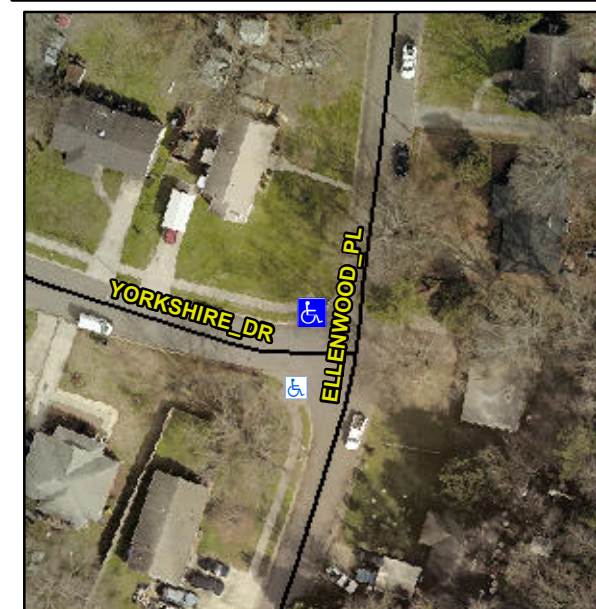
Not Found, R304.2.2

Compliance	Description	Data	Compliance	Description	Data
N/A	Ramp Length (in)	60.0	No	Ramp Slope (%)	9.3
Yes	Ramp Width (in)	48.0	Yes	Ramp XSlope (%)	0.1
N/A	Flare Type LT	N/A	N/A	Flare Type RT	N/A
N/A	Flare Slope LT (%)	N/A	N/A	Flare Slope RT (%)	N/A
N/A	Flare Traversable LT?	N/A	N/A	Flare Traversable RT?	N/A
N/A	Landing Length (in)	N/A	N/A	DWS Provided?	N/A
N/A	Landing Width (in)	N/A	N/A	DWS Contrast?	N/A
N/A	Landing Slope (%)	N/A	N/A	DWS Length (in)	N/A
N/A	Landing X Slope (%)	N/A	N/A	DWS Full Width?	N/A
N/A	Landing Curb? (Y/N)	N/A	N/A	DWS Offset (in)	N/A
N/A	Shared Landing?	N/A			
N/A	Gutter Ponding?	N/A	N/A	Gutter Slope (%)	N/A
N/A	Gutter Lip Ht (in)	N/A	N/A	Gutter X Slope (%)	N/A
N/A	Painted X Walk1?	No	N/A	Painted X Walk2?	No
	X Walk 1 Direction	To S		X Walk 2 Direction	To E
N/A	X Walk 1 Width (in)	N/A	N/A	X Walk 2 Width (in)	N/A
	X Walk 1 Slope (%)	6.0		X Walk 2 Slope (%)	0.7
	X Walk 1 X Slope (%)	0.4		X Walk 2 X Slope (%)	1.9

N/A	Ramp inside XWalk1?	N/A	N/A	Ramp inside XWalk2?	N/A
	Road Slope (%)	2.3	N/A	Clear Space?	N/A
	Road X Slope (%)	3.8	N/A	Clear Space to XWalk (in)	N/A
N/A	Any Obstructions?	N/A	N/A	Storm Grate/Utility Hazard?	N/A
	Obstruction Type			Storm Grate/Utility Type	
		N/A			N/A
		Yes		Surface Condition? (G/P)	Good

Remove & Replace Curb Ramp With Two New Directional Ramps or Equivalent.

Total Cost: \$ 3200.00
