## **Access Compliance Report Public Rights-of-Way** (Curb Ramps)

Intersection ID: 30323 Main Street: SHINKANSEN DR **Cross Street: STOURBRIDGE LION DR** Location: S ADA ID: 1788E9B85CC8 Ramp Type: PerpDiag Initial Pass/Fail: Fail **Overall Compliance: No Severity Score:** 8.75

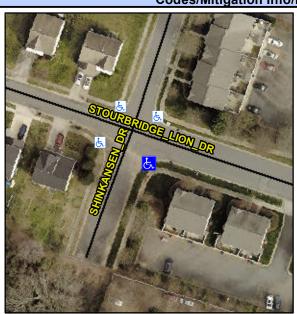
Fleid Measurements/Component Compliance						
	Compliance Description		Data	Compliance Description		Data
	N/A	Ramp Length (in)	72.5	Yes	Ramp Slope (%)	5.8
	No	Ramp Width (in)	42.5	Yes	Ramp XSlope (%)	0.8
	N/A	Flare Type LT	N/A	N/A	Flare Type RT	N/A
	N/A	Flare Slope LT (%)	N/A	N/A	Flare Slope RT (%)	N/A
	N/A	Flare Traversable LT?	N/A	N/A	Flare Traversable RT?	N/A
	N/A	Landing Length (in)	N/A	N/A	DWS Provided?	N/A
	N/A	Landing Width (in)	N/A	N/A	DWS Contrast?	N/A
	N/A	Landing Slope (%)	N/A	N/A	DWS Length (in)	N/A
	N/A	Landing X Slope (%)	N/A	N/A	DWS Full Width?	N/A
	N/A	Landing Curb? (Y/N)	N/A	N/A	DWS Offset (in)	N/A
	N/A	Shared Landing?	N/A			
	N/A	Gutter Ponding?	N/A	N/A	Gutter Slope (%)	N/A
	N/A	Gutter Lip Ht (in)	N/A	N/A	Gutter X Slope (%)	N/A
	N/A	Painted X Walk1?	No	N/A	Painted X Walk2?	No
		X Walk 1 Direction	То Е		X Walk 2 Direction	To W
	N/A	X Walk 1 Width (in)	N/A	N/A	X Walk 2 Width (in)	N/A
		X Walk 1 Slope (%)	0.7		X Walk 2 Slope (%)	0.6

X Walk 1 X Slope (%)	1.7		X Walk 2 X Slope (%)	0.0
	N/A	Ramp inside XWalk1?	N/A	N/A	Ramp inside XWalk2?	N/A
		Road Slope (%)	0.2	N/A	Clear Space?	N/A
		Road X Slope (%)	0.5	N/A	Clear Space to XWalk (in)	N/A
	N/A	Any Obstructions?	N/A	N/A	Storm Grate/Utility Hazard?	N/A

Possible Solutions: Remove & Replace Curb Ramp With Two New Directional Ramps or Equivalent. Surveyor Notes: N/A PROW/ADA: Not Found, R304.5.1
