Access Compliance Report Public Rights-of-Way (Curb Ramps)

| | | | | | | | | | I | |
|--|---|--|---|---|---|---|---|---|---|--|
| Intersection ID: 4864 Main Street: HARRINGTON_WOODS_RD | | | | | KEATON_AV | Location: | NW | | | |
| ADA ID: 178C66ABA | ID: 178C66ABA699 Ramp Type: PerpDiag | | | nitial Pass/Fail: Fail Overall Compliance: No | | | | o Severity Score: | 37.5 | |

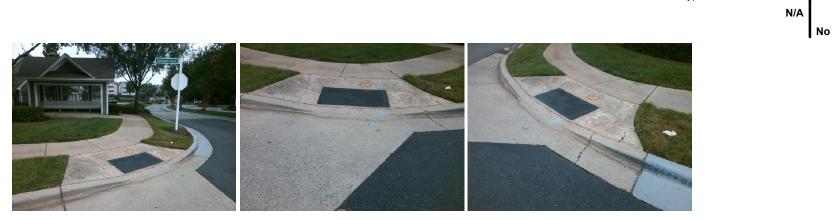
| | | | | | | | | | I | |
|--|---|--|---|---|---|---|---|---|---|--|
| | | Remove & Replace Curb Ramp With Two New Directional Ramps or Equivalent. | 'ith | N/A | Ramp Length (in) | 50.0 | No | Ramp Slope (%) | <u>Data</u> 9.7 | |
| | | | | No | Ramp Width (in) | 42.0 | No | Ramp XSlope (%) | 3.8 | |

o Surface Condition? (G/P)

Poor

| | | | | | | | | | I | |
|--|---|--|---|---|---|---|---|---|---|--|
| | | Total Cost: \$ 32 | 200.00 | | Obstruction Type | | | Storm Grate/Utility Type | | |
