Access Compliance Report Public Rights-of-Way (Curb Ramps)

Main Street: WOOD DUCK CROSSING DR Cross Street: WINGED TEAL RD Intersection ID: 47454 Location: SE

Overall Compliance: No Severity Score: ADA ID: 179321D9DDB4 Ramp Type: BlendTrans1 Initial Pass/Fail: Fail 8.75

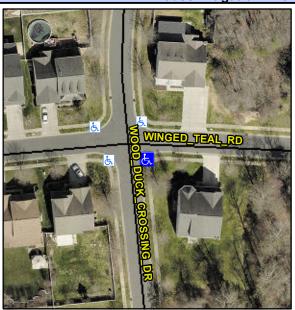
Compliance Description Data Compliance Description Data Ramp Length (in) Yes N/A 50.5 BlendTrans Slope (%) 4.0 46.5 Yes No Ramp Width (in) BlendTrans XSlope (%) 0.9 N/A N/A Flare Type LT N/A Flare Type RT N/A N/A Flare Slope LT (%) N/A N/A Flare Slope RT (%) N/A N/A Flare Traversable LT? N/A N/A Flare Traversable RT? N/A N/A Landing Length (in) N/A N/A **DWS Provided?** N/A N/A Landing Width (in) N/A N/A **DWS Contrast?** N/A N/A N/A N/A Landing Slope (%) DWS Length (in) N/A N/A Landing X Slope (%) N/A N/A DWS Full Width? N/A N/A Landing Curb? (Y/N) N/A N/A DWS Offset (in) N/A N/A N/A Shared Landing? N/A **Gutter Ponding?** N/A N/A Gutter Slope (%) N/A N/A Gutter Lip Ht (in) N/A N/A Gutter X Slope (%) N/A N/A Painted X Walk1? No N/A Painted X Walk2? No X Walk 1 Direction To N X Walk 2 Direction To W N/A X Walk 1 Width (in) X Walk 2 Width (in) N/A X Walk 1 Slope (%) 4.7 X Walk 2 Slope (%) 4.9 X Walk 2 X Slope (%) X Walk 1 X Slope (%) 0.9 2.6 N/A N/A Ramp inside XWalk2? N/A N/A Ramp inside XWalk1? Road Slope (%) 0.1 Clear Space? N/A N/A Road X Slope (%) 9.0 Clear Space to XWalk (in) N/A N/A N/A N/A Any Obstructions? Storm Grate/Utility Hazard? N/A **Obstruction Type** Storm Grate/Utility Type N/A N/A Yes Surface Condition? (G/P) Good No 10.5 Curb Slope (%)

Possible Solutions: Remove & Replace Curb Ramp With Two New Directional Ramps or Equivalent. Surveyor Notes: N/A Not Found, R304.5.1
