Access Compliance Report

Public Rights-of-Way

(Curb Ramps)

Intersection ID: 11799	Main Street: MECKLENBURG_AV	Cross Street: NORCROSS_PL	Location: SW
ADA ID: 1794BC23B153	Ramp Type: Directional1	Initial Pass/Fail: Fail	Overall Compliance: No
		Severity Score: 12.5

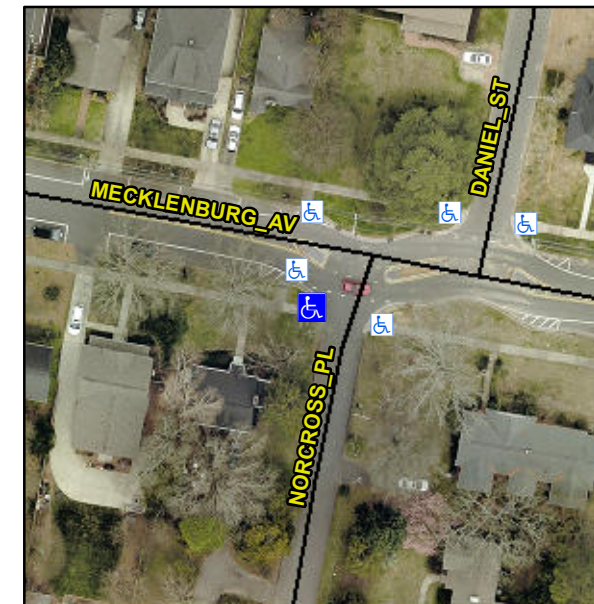
Compliance	Description	Data	Compliance	Description	Data
N/A	Ramp Length (in)	114.0	N/A	Grade Break?	N/A
Yes	Ramp Width (in)	59.0	N/A	Grade Break Slope (%)	0.0
No	Ramp Slope (%)	8.4	N/A	Grade Break XSlope (%)	0.0
Yes	Ramp XSlope (%)	0.9			
N/A	Flare Type LT	N/A	N/A	Flare Type RT	N/A
N/A	Flare Slope LT (%)	N/A	N/A	Flare Slope RT (%)	0.0
N/A	Flare Traversable LT?	N/A	N/A	Flare Traversable RT?	N/A
N/A	Landing Length (in)	0.0	N/A	DWS Provided?	N/A
N/A	Landing Width (in)	0.0	N/A	DWS Contrast?	N/A
N/A	Landing Slope (%)	0.0	N/A	DWS Length (in)	N/A
N/A	Landing X Slope (%)	0.0	N/A	DWS Full Width?	N/A
N/A	Landing Curb? (Y/N)	N/A	N/A	DWS Offset LT (in)	N/A
N/A	Shared Landing?	N/A	N/A	DWS Offset RT (in)	N/A
N/A	Gutter Ponding?	0.0	N/A	Gutter Slope (%)	N/A
N/A	Gutter Lip Ht (in)	0.0	N/A	Gutter X Slope (%)	N/A
N/A	Painted X Walk1?	No		Road Slope (%)	1.3
	X Walk 1 Direction	To E		Road X Slope (%)	2.4
	X Walk 1 Width (in)	N/A		Clear Space?	N/A

X Walk 1 Slope (%)	1.3	N/A	Clear Space to XWalk (in)	N/A
	X Walk 1 X Slope (%)	2.4	N/A	Storm Grate/Utility Hazard?	N/A
N/A	Ramp inside XWalk1?	N/A		Storm Grate/Utility Type	
N/A	Any Obstructions?	N/A			N/A
	Obstruction Type		Yes	Surface Condition? (G/P)	Good
			N/A	Curb Slope (%)	12.1

Possible Solutions:

Remove & Replace Entire Ramp.
