# Access Compliance Report

## Public Rights-of-Way

### (Curb Ramps)

Intersection ID: 17974	Main Street: OLD_PINEVILLE_RD	Cross Street: SPRINGBROOK_RD	Location: NW
ADA ID: 1796791662D6	Ramp Type: Directional1	Initial Pass/Fail: Fail	Overall Compliance: No
		Severity Score: 1.25

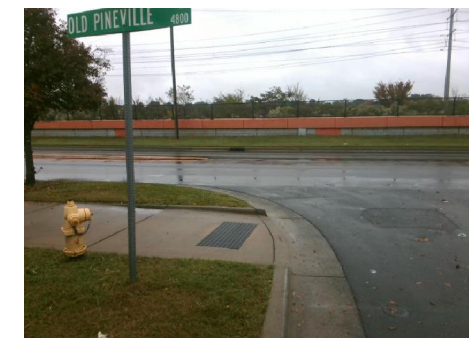
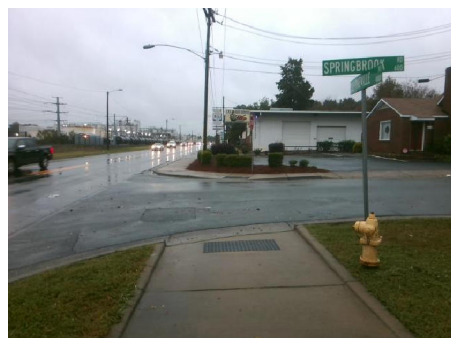
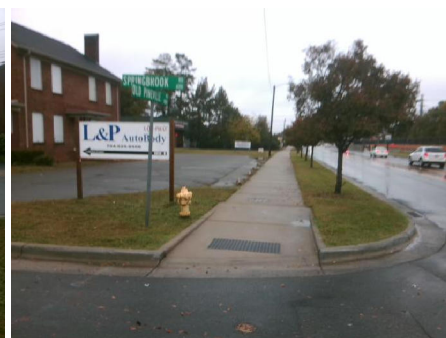
Compliance	Description	Data	Compliance	Description	Data
N/A	Ramp Length (in)	73.0	N/A	Grade Break?	N/A
Yes	Ramp Width (in)	92.0	N/A	Grade Break Slope (%)	0.0
Yes	Ramp Slope (%)	1.1	N/A	Grade Break XSlope (%)	0.0
No	Ramp XSlope (%)	3.2			
N/A	Flare Type LT	N/A	N/A	Flare Type RT	N/A
N/A	Flare Slope LT (%)	N/A	N/A	Flare Slope RT (%)	0.0
N/A	Flare Traversable LT?	N/A	N/A	Flare Traversable RT?	N/A
N/A	Landing Length (in)	0.0	N/A	DWS Provided?	N/A
N/A	Landing Width (in)	0.0	N/A	DWS Contrast?	N/A
N/A	Landing Slope (%)	0.0	N/A	DWS Length (in)	N/A
N/A	Landing X Slope (%)	0.0	N/A	DWS Full Width?	N/A
N/A	Landing Curb? (Y/N)	N/A	N/A	DWS Offset LT (in)	N/A
N/A	Shared Landing?	N/A	N/A	DWS Offset RT (in)	N/A
N/A	Gutter Ponding?	0.0	N/A	Gutter Slope (%)	N/A
N/A	Gutter Lip Ht (in)	0.0	N/A	Gutter X Slope (%)	N/A
N/A	Painted X Walk1?	No		Road Slope (%)	2.4
	X Walk 1 Direction	To S		Road X Slope (%)	3.8
	X Walk 1 Width (in)	N/A		Clear Space?	N/A

X Walk 1 Slope (%)	2.4	N/A	Clear Space to XWalk (in)	N/A
	X Walk 1 X Slope (%)	3.8	N/A	Storm Grate/Utility Hazard?	N/A
N/A	Ramp inside XWalk1?	N/A		Storm Grate/Utility Type	
N/A	Any Obstructions?	N/A			N/A
	Obstruction Type		Yes	Surface Condition? (G/P)	Good
			N/A	Curb Slope (%)	18.1

**Remove & Replace Entire Ramp.**

**R304.5.3**
