Access Compliance Report Public Rights-of-Way (Curb Ramps)

Intersection ID: 12516 Main Street: ARTY AV **Cross Street: W MOREHEAD ST** Location: SW ADA ID: 17968D65A5C2 Ramp Type: BlendTrans1 Initial Pass/Fail: Fail **Overall Compliance: No Severity Score:** 8.75

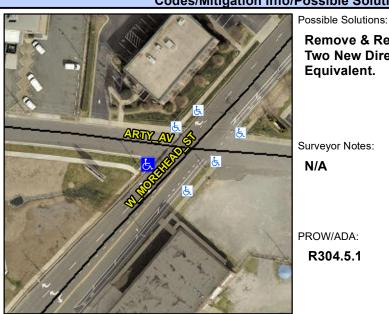
Comp	Compliance Description D		Comp	liance Description	Data
N/A	Ramp Length (in)	48.0	Yes	BlendTrans Slope (%)	4.0
No	Ramp Width (in)	47.5	Yes	BlendTrans XSlope (%)	1.1
N/A	Flare Type LT	N/A	N/A	Flare Type RT	N/A
N/A	Flare Slope LT (%)	N/A	N/A	Flare Slope RT (%)	N/A
N/A	Flare Traversable LT?	N/A	N/A	Flare Traversable RT?	N/A
N/A	Landing Length (in)	N/A	N/A	DWS Provided?	N/A
N/A	Landing Width (in)	N/A	N/A	DWS Contrast?	N/A
N/A	Landing Slope (%)	N/A	N/A	DWS Length (in)	N/A
N/A	Landing X Slope (%)	N/A	N/A	DWS Full Width?	N/A
N/A	Landing Curb? (Y/N)	N/A	N/A	DWS Offset (in)	N/A
N/A	Shared Landing?	N/A			
N/A	Gutter Ponding?	N/A	N/A	Gutter Slope (%)	N/A
N/A	Gutter Lip Ht (in)	N/A	N/A	Gutter X Slope (%)	N/A
N/A	Painted X Walk1?	No	N/A	Painted X Walk2?	No
	X Walk 1 Direction	To SE		X Walk 2 Direction	To NE
	X Walk 1 Width (in)	N/A		X Walk 2 Width (in)	N/A
	X Walk 1 Slope (%)	3.2		X Walk 2 Slope (%)	1.3
	X Walk 1 X Slope (%)	3.2		X Walk 2 X Slope (%)	3.0

N/A	Ramp inside XWalk1?	N/A	N/A	Ramp inside XWalk2?	N/A
	Road Slope (%)	1.6		Clear Space?	N/A
	Road X Slope (%)	3.0	N/A	Clear Space to XWalk (in)	N/A
N/A	Any Obstructions?	N/A	N/A	Storm Grate/Utility Hazard?	N/A
	Obstruction Type			Storm Grate/Utility Type	
		N/A			N/A
			Yes	Surface Condition? (G/P)	Good
	COOLEY NAMAZDA		N/A	Curb Slope (%)	0.1

Remove & Replace Curb Ramp With **Two New Directional Ramps or** Equivalent.

R304.5.1
