# Access Compliance Report

## Public Rights-of-Way

### (Curb Ramps)

Intersection ID: 11613	Main Street: W_7TH_ST	Cross Street: N_GRAHAM_ST	Location:	S
ADA ID: 1799BBF23196	Ramp Type: Directional2	Initial Pass/Fail: Fail	Overall Compliance: No	Severity Score: 25
Codes/Mitigation Info/Possible Solution		Field Measurements/Component Compliance

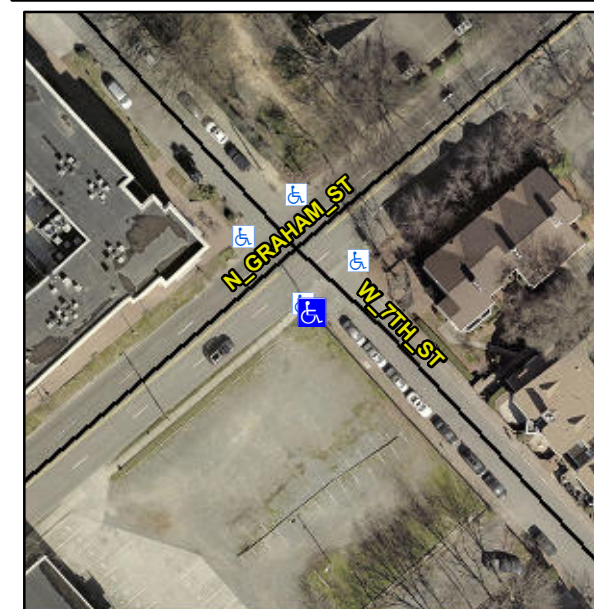
Surveyor Notes:

**VEGETATION OVERGROWTH**

PROW/ADA:

**R304.2.2, R304.5.3**

Compliance	Description	Data	Compliance	Description	Data
N/A	Ramp Length (in)	90.0	N/A	Grade Break?	N/A
Yes	Ramp Width (in)	48.0	N/A	Grade Break Slope (%)	0.0
No	Ramp Slope (%)	9.7	N/A	Grade Break XSlope (%)	0.0
No	Ramp XSlope (%)	6.6			
N/A	Flare Type LT	N/A	N/A	Flare Type RT	N/A
N/A	Flare Slope LT (%)	N/A	N/A	Flare Slope RT (%)	0.0
N/A	Flare Traversable LT?	N/A	N/A	Flare Traversable RT?	N/A
N/A	Landing Length (in)	0.0	N/A	DWS Provided?	N/A
N/A	Landing Width (in)	0.0	N/A	DWS Contrast?	N/A
N/A	Landing Slope (%)	0.0	N/A	DWS Length (in)	N/A
N/A	Landing X Slope (%)	0.0	N/A	DWS Full Width?	N/A
N/A	Landing Curb? (Y/N)	N/A	N/A	DWS Offset LT (in)	N/A
N/A	Shared Landing?	N/A	N/A	DWS Offset RT (in)	N/A
N/A	Gutter Ponding?	0.0	N/A	Gutter Slope (%)	N/A
N/A	Gutter Lip Ht (in)	0.0	N/A	Gutter X Slope (%)	N/A
N/A	Painted X Walk1?	No		Road Slope (%)	0.7
	X Walk 1 Direction	To NW		Road X Slope (%)	3.3
	X Walk 1 Width (in)	N/A		Clear Space?	N/A

X Walk 1 Slope (%)	0.7	N/A	Clear Space to XWalk (in)	N/A
	X Walk 1 X Slope (%)	3.3	N/A	Storm Grate/Utility Hazard?	N/A
N/A	Ramp inside XWalk1?	N/A		Storm Grate/Utility Type	
N/A	Any Obstructions?	N/A			N/A
	Obstruction Type		Yes	Surface Condition? (G/P)	Good
			N/A	Curb Slope (%)	11.0

Possible Solutions:

**Remove & Replace Entire Ramp.**

Total Cost: \$ 1800.00
