Access Compliance Report

Public Rights-of-Way

(Curb Ramps)

Intersection ID: 27719	Main Street: BREM_LN	Cross Street: FLENNIGAN_WY	Location: NW
ADA ID: 179AF672F087	Ramp Type: Perp	Initial Pass/Fail: Fail	Overall Compliance: No
		Severity Score: 10

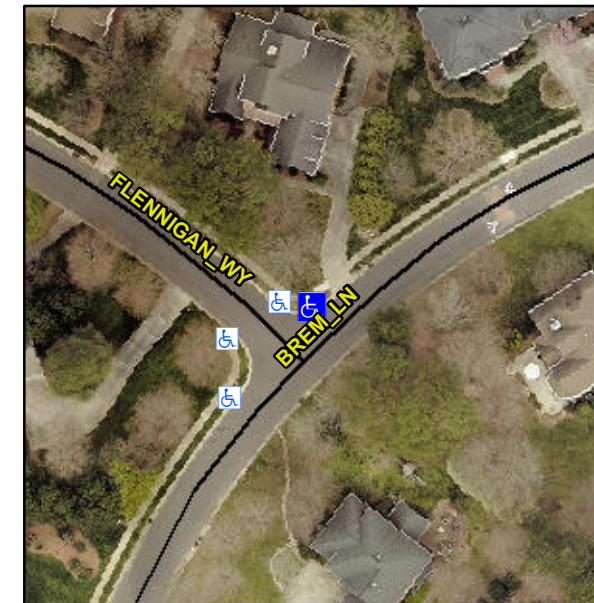
Not Found, R304.5.1, R304.5.3

Compliance	Description	Data	Compliance	Description	Data
N/A	Ramp Length (in)	99.0	Yes	Ramp Slope (%)	5.5
No	Ramp Width (in)	36.0	No	Ramp XSlope (%)	3.4
N/A	Flare Type LT	N/A	N/A	Flare Type RT	N/A
N/A	Flare Slope LT (%)	N/A	N/A	Flare Slope RT (%)	N/A
N/A	Flare Traversable LT?	N/A	N/A	Flare Traversable RT?	N/A
N/A	Landing Length (in)	N/A	N/A	DWS Provided?	N/A
N/A	Landing Width (in)	N/A	N/A	DWS Contrast?	N/A
N/A	Landing Slope (%)	N/A	N/A	DWS Length (in)	N/A
N/A	Landing X Slope (%)	N/A	N/A	DWS Full Width?	N/A
N/A	Landing Curb? (Y/N)	N/A	N/A	DWS Offset (in)	N/A
N/A	Shared Landing?	N/A			
N/A	Gutter Ponding?	N/A	N/A	Gutter Slope (%)	N/A
N/A	Gutter Lip Ht (in)	N/A	N/A	Gutter X Slope (%)	N/A
N/A	Painted X Walk1?	No	N/A	Painted X Walk2?	N/A
	X Walk 1 Direction	To SE		X Walk 2 Direction	N/A
N/A	X Walk 1 Width (in)	N/A	N/A	X Walk 2 Width (in)	N/A
	X Walk 1 Slope (%)	2.2		X Walk 2 Slope (%)	N/A
	X Walk 1 X Slope (%)	0.8		X Walk 2 X Slope (%)	N/A

Remove & Replace Entire Ramp.
