# Access Compliance Report

## Public Rights-of-Way

### (Curb Ramps)

Intersection ID: 10022596	Main Street: CARMEL_RD	Cross Street: N/A	Location: SW
ADA ID: 17A18276D4C5	Ramp Type: Para	Initial Pass/Fail: Fail	Overall Compliance: No
			Severity Score: 13.75

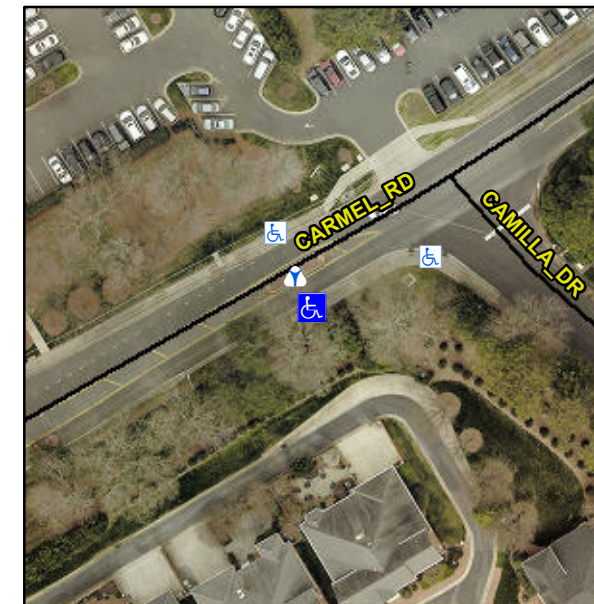
Compliance	Description	Data	Compliance	Description	Data
N/A	Ramp Length LT (in)	<b>69.0</b>	N/A	Ramp Length RT (in)	<b>72.0</b>
Yes	Ramp Width LT (in)	<b>53.0</b>	Yes	Ramp Width RT (in)	<b>53.0</b>
Yes	Ramp Slope LT (%)	<b>6.5</b>	No	Ramp Slope RT (%)	<b>8.6</b>
Yes	Ramp XSlope LT (%)	<b>1.1</b>	No	Ramp XSlope RT (%)	<b>2.5</b>
N/A	Landing Length (in)	<b>N/A</b>	N/A	DWS Provided?	<b>N/A</b>
N/A	Landing Width (in)	<b>N/A</b>	N/A	DWS Contrast?	<b>N/A</b>
N/A	Landing Slope (%)	<b>N/A</b>	N/A	DWS Length (in)	<b>N/A</b>
N/A	Landing X Slope (%)	<b>N/A</b>	N/A	DWS Full Width?	<b>N/A</b>
N/A	Landing Curb? (Y/N)	<b>N/A</b>	N/A	DWS Offset (in)	<b>N/A</b>
N/A	Shared Landing?	<b>N/A</b>			
N/A	Gutter Ponding?	<b>N/A</b>	N/A	Gutter Slope (%)	<b>N/A</b>
N/A	Gutter Lip Ht (in)	<b>N/A</b>	N/A	Gutter X Slope (%)	<b>N/A</b>
N/A	Painted X Walk1?	<b>No</b>	N/A	Painted X Walk2?	<b>N/A</b>
	X Walk 1 Direction	<b>To NW</b>		X Walk 2 Direction	<b>N/A</b>

N/A	X Walk 1 Width (in)	<b>N/A</b>	N/A	X Walk 2 Width (in)	<b>N/A</b>
	X Walk 1 Slope (%)	<b>0.4</b>		X Walk 2 Slope (%)	<b>N/A</b>
	X Walk 1 X Slope (%)	<b>0.3</b>		X Walk 2 X Slope (%)	<b>N/A</b>
N/A	Ramp inside XWalk1?	<b>N/A</b>	N/A	Ramp inside XWalk2?	<b>N/A</b>
	Road Slope (%)	<b>N/A</b>	N/A	Clear Space?	<b>N/A</b>
	Road X Slope (%)	<b>N/A</b>	N/A	Clear Space to XWalk (in)	<b>N/A</b>
N/A	Any Obstructions?	<b>N/A</b>	N/A	Storm Grate/Utility Hazard?	<b>N/A</b>
	Obstruction Type			Storm Grate/Utility Type	
		<b>N/A</b>			<b>N/A</b>
			Yes	Surface Condition? (G/P)	<b>Good</b>
			N/A	Curb Slope (%)	<b>8.1</b>

**Remove & Replace Entire Ramp.**
