Access Compliance Report

Public Rights-of-Way

(Curb Ramps)

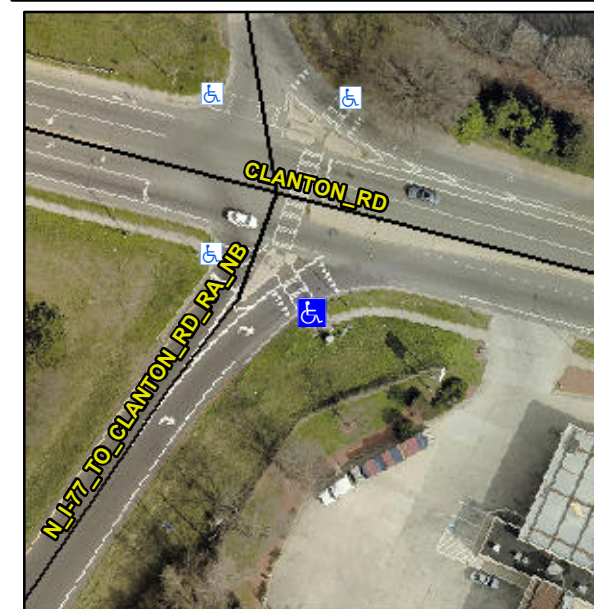
Intersection ID: 15542	Main Street: CLANTON_RD	Cross Street: N_I-77_TO_CLANTON_RD_RA	Location: S
ADA ID: 17C0C43C605D	Ramp Type: Perp	Initial Pass/Fail: Fail	Overall Compliance: No
Severity Score: 21.25			
Codes/Mitigation Info/Possible Solution		Field Measurements/Component Compliance

Not Found, R304.5.1, R304.5.3

Compliance	Description	Data	Compliance	Description	Data
N/A	Ramp Length (in)	92.0	Yes	Ramp Slope (%)	6.2
No	Ramp Width (in)	46.5	No	Ramp XSlope (%)	5.3
N/A	Flare Type LT	N/A	N/A	Flare Type RT	N/A
N/A	Flare Slope LT (%)	N/A	N/A	Flare Slope RT (%)	N/A
N/A	Flare Traversable LT?	N/A	N/A	Flare Traversable RT?	N/A
N/A	Landing Length (in)	N/A	N/A	DWS Provided?	N/A
N/A	Landing Width (in)	N/A	N/A	DWS Contrast?	N/A
N/A	Landing Slope (%)	N/A	N/A	DWS Length (in)	N/A
N/A	Landing X Slope (%)	N/A	N/A	DWS Full Width?	N/A
N/A	Landing Curb? (Y/N)	N/A	N/A	DWS Offset (in)	N/A
N/A	Shared Landing?	N/A			
N/A	Gutter Ponding?	N/A	N/A	Gutter Slope (%)	N/A
N/A	Gutter Lip Ht (in)	N/A	N/A	Gutter X Slope (%)	N/A
N/A	Painted X Walk1?	Yes	N/A	Painted X Walk2?	N/A
	X Walk 1 Direction	To NW		X Walk 2 Direction	N/A
N/A	X Walk 1 Width (in)	112.0	N/A	X Walk 2 Width (in)	N/A
	X Walk 1 Slope (%)	3.8		X Walk 2 Slope (%)	N/A
	X Walk 1 X Slope (%)	2.8		X Walk 2 X Slope (%)	N/A

N/A	Ramp inside XWalk1?	Yes	N/A	Ramp inside XWalk2?	N/A
	Road Slope (%)	N/A	N/A	Clear Space?	N/A
	Road X Slope (%)	N/A	N/A	Clear Space to XWalk (in)	N/A
N/A	Any Obstructions?	N/A	N/A	Storm Grate/Utility Hazard?	N/A
	Obstruction Type			Storm Grate/Utility Type	
		N/A			N/A
			Yes	Surface Condition? (G/P)	Good

Remove & Replace Entire Ramp.
