# Access Compliance Report

## Public Rights-of-Way

### (Curb Ramps)

| Intersection ID: 52449 | Main Street: TRANQUIL_OAK_PL | Cross Street: PAT_GARRETT_ST | Location: NW |

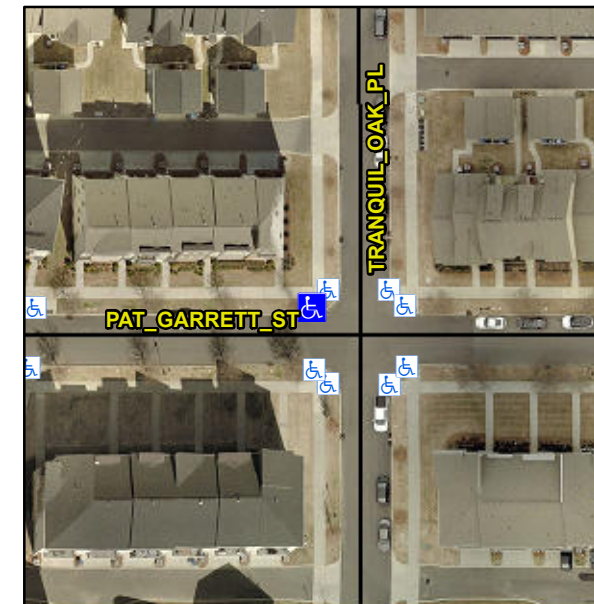
| ADA ID: 17C5AC952EFB | Ramp Type: Directional1 | Initial Pass/Fail: Pass | Overall Compliance: No |
| | | Severity Score: 10 | |

**R304.5.2, R305.1.4, R305.2, R302.7.2**

| Compliance | Description | Data | Compliance | Description | Data |
|---|---|---|---|---|---|
| Yes | Landing X Slope (%) | 1.1 | No | DWS Full Width? | No |
| No | Gutter Lip Ht (in) | 0.5 | Yes | Gutter X Slope (%) | 1.4 |

**Remove & Replace Entire Ramp.  
Grind Gutter Lip.**

\$ 1800.00

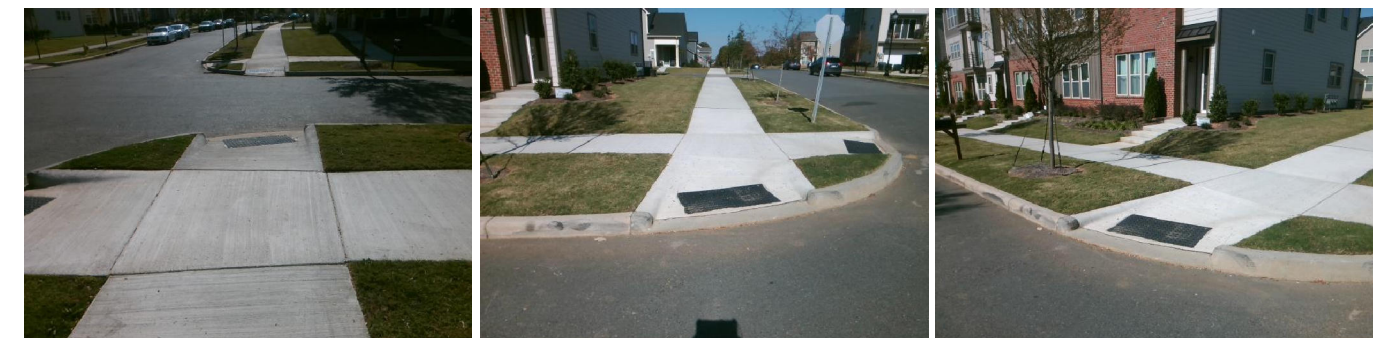
| Compliance | Description | Data | Compliance | Description | Data |
|---|---|---|---|---|---|
| N/A | Ramp Length (in) | 67.0 | No | Grade Break? | No |

Possible Solutions:
