Access Compliance Report

Public Rights-of-Way

(Curb Ramps)

Intersection ID: 27824	Main Street: BALLANTYNE CROSSING AV	Cross Street: TRADING PATH WY	Location: S
ADA ID: 17CD5ED8860C	Ramp Type: PerpDiag	Initial Pass/Fail: Fail	Overall Compliance: No
Severity Score: 8.75			
Codes/Mitigation Info/Possible Solution		Field Measurements/Component Compliance

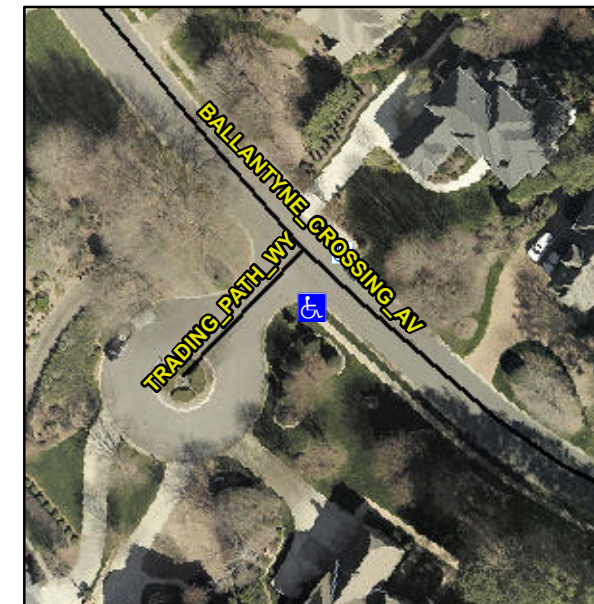
Not Found, R304.5.1

Compliance	Description	Data	Compliance	Description	Data
N/A	Ramp Length (in)	48.0	Yes	Ramp Slope (%)	7.6
No	Ramp Width (in)	43.0	Yes	Ramp XSlope (%)	1.4
N/A	Flare Type LT	N/A	N/A	Flare Type RT	N/A
N/A	Flare Slope LT (%)	N/A	N/A	Flare Slope RT (%)	N/A
N/A	Flare Traversable LT?	N/A	N/A	Flare Traversable RT?	N/A
N/A	Landing Length (in)	N/A	N/A	DWS Provided?	N/A
N/A	Landing Width (in)	N/A	N/A	DWS Contrast?	N/A
N/A	Landing Slope (%)	N/A	N/A	DWS Length (in)	N/A
N/A	Landing X Slope (%)	N/A	N/A	DWS Full Width?	N/A
N/A	Landing Curb? (Y/N)	N/A	N/A	DWS Offset (in)	N/A
N/A	Shared Landing?	N/A			
N/A	Gutter Ponding?	N/A	N/A	Gutter Slope (%)	N/A
N/A	Gutter Lip Ht (in)	N/A	N/A	Gutter X Slope (%)	N/A
N/A	Painted X Walk1?	No	N/A	Painted X Walk2?	No
	X Walk 1 Direction	To NE		X Walk 2 Direction	To NW
N/A	X Walk 1 Width (in)	N/A	N/A	X Walk 2 Width (in)	N/A
	X Walk 1 Slope (%)	8.5		X Walk 2 Slope (%)	3.6
	X Walk 1 X Slope (%)	1.5		X Walk 2 X Slope (%)	5.7

N/A	Ramp inside XWalk1?	N/A	N/A	Ramp inside XWalk2?	N/A
	Road Slope (%)	1.5	N/A	Clear Space?	N/A
	Road X Slope (%)	8.2	N/A	Clear Space to XWalk (in)	N/A
N/A	Any Obstructions?	N/A	N/A	Storm Grate/Utility Hazard?	N/A
	Obstruction Type			Storm Grate/Utility Type	
		N/A			N/A
			Yes	Surface Condition? (G/P)	Good

Remove & Replace Curb Ramp With Two New Directional Ramps or Equivalent.

Total Cost: \$ 3200.00
