Access Compliance Report

Public Rights-of-Way

(Curb Ramps)

Intersection ID: 24925	Main Street: BIRNEN_DR	Cross Street: GLEN_LAUREL_WY	Location: NW
ADA ID: 17CFD9F40CC0	Ramp Type: PerpDiag	Initial Pass/Fail: Fail	Overall Compliance: No
			Severity Score: 33.75

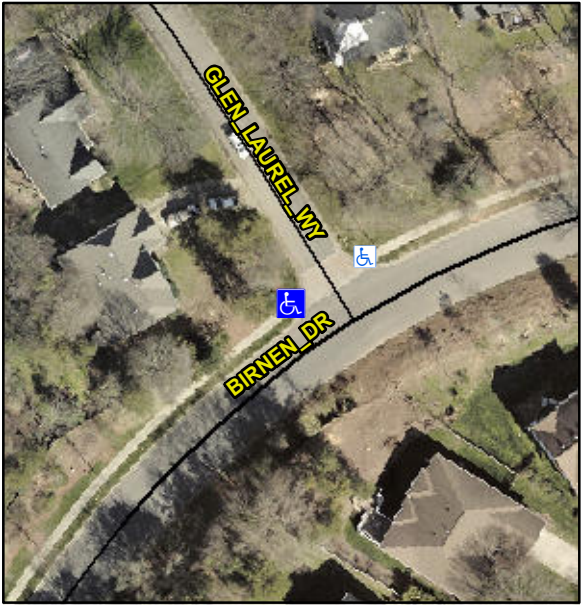
Possible Solutions:		Compliance	Description	Data
	Remove & Replace Curb Ramp With Two New Directional Ramps or Equivalent.		No	Ramp Length (in)	76.0
			No	Ramp Width (in)	43.0
			N/A	Flare Type LT	N/A
			N/A	Flare Slope LT (%)	N/A
			N/A	Flare Traversable LT?	N/A
			N/A	Landing Length (in)	N/A
			N/A	Landing Width (in)	N/A
			N/A	Landing Slope (%)	N/A
			N/A	Landing X Slope (%)	N/A
<p>Surveyor Notes:</p> <p>N/A</p> <p>PROW/ADA:</p> <p>Not Found, R304.5.1, R304.2.2, R304.5.3</p>			N/A	Flare Type RT	N/A
			N/A	Flare Slope RT (%)	N/A
			N/A	Flare Traversable RT?	N/A
			N/A	DWS Provided?	N/A
			N/A	DWS Contrast?	N/A
			N/A	DWS Length (in)	N/A
			N/A	DWS Full Width?	N/A
			N/A	DWS Offset (in)	N/A
			N/A	Gutter Ponding?	N/A
			N/A	Gutter Lip Ht (in)	N/A
<p>Total Cost:</p> <p>\$ 3200.00</p>			No	Painted X Walk1?	No
				X Walk 1 Direction	To S

N/A	X Walk 1 Width (in)	N/A
			6.4	X Walk 1 Slope (%)	3.5
			3.5	X Walk 1 X Slope (%)	7.7
			N/A	Ramp inside XWalk1?	N/A
			9.9	Road Slope (%)	N/A
			2.8	Road X Slope (%)	N/A
			N/A	Any Obstructions?	N/A
				Obstruction Type	
			N/A	Storm Grate/Utility Hazard?	N/A
			N/A	Storm Grate/Utility Type	N/A
			Yes	Surface Condition? (G/P)	Good
