## Access Compliance Report Public Rights-of-Way (Curb Ramps)

Intersection ID: N/A Main Street: PHILLIPS\_PLACE\_CT Cross Street: CAMERON\_VALLEY\_PY Location: SE

ADA ID: 17D4CA338660 Ramp Type: Perp Initial Pass/Fail: Fail Overall Compliance: No Severity Score: 1.25

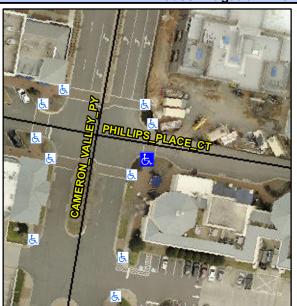
Compliance         Description         Data         Compliance         Description           N/A         Ramp Length (in)         31.0         Yes         Ramp Slope (%)           Yes         Ramp Width (in)         150.0         No         Ramp XSlope (%)           N/A         Flare Type LT         N/A         N/A         Flare Type RT	0ata 8.0 4.7 N/A
Yes Ramp Width (in) 150.0 No Ramp XSlope (%)	4.7
N/A Flare Type LT N/A N/A Flare Type RT	N/A
N/A Flare Slope LT (%) N/A N/A Flare Slope RT (%)	N/A
N/A Flare Traversable LT? N/A N/A Flare Traversable RT?	N/A
N/A Landing Length (in) N/A N/A DWS Provided?	N/A
N/A Landing Width (in) N/A N/A DWS Contrast?	N/A
N/A Landing Slope (%) N/A N/A DWS Length (in)	N/A
N/A Landing X Slope (%) N/A N/A DWS Full Width?	N/A
N/A Landing Curb? (Y/N) N/A N/A DWS Offset (in)	N/A
N/A Shared Landing? N/A	
N/A Gutter Ponding? N/A N/A Gutter Slope (%)	N/A
N/A Gutter Lip Ht (in) 0.5 N/A Gutter X Slope (%)	N/A

N/A Painted X Walk1? Yes N/A Painted X Walk2?	N/A
X Walk 1 Direction To NE X Walk 2 Direction	N/A
N/A X Walk 1 Width (in) 146.0 N/A X Walk 2 Width (in)	N/A
X Walk 1 Slope (%) 0.8 X Walk 2 Slope (%)	N/A
X Walk 1 X Slope (%) 3.6 X Walk 2 X Slope (%)	N/A
N/A Ramp inside XWalk1? Yes N/A Ramp inside XWalk2?	N/A
Road Slope (%) N/A N/A Clear Space?	N/A
Road X Slope (%) N/A N/A Clear Space to XWalk (in)	N/A
N/A Any Obstructions? N/A N/A Storm Grate/Utility Hazard?	N/A
Obstruction Type Storm Grate/Utility Type	
N/A	N/A
Yes Surface Condition? (G/P) G	ood

i ossible solution	
Possible Solutions:	Com
Remove & Replace Entire Ramp.	N/A
·	Yes
	N/A
	N/A
	N/A
	N/A
Surveyor Notes:	N/A
N/A	N/A
	N/A
	N/A
	N/A
PROW/ADA:	N/A
Not Found, R304.5.3	N/A
,	N/A
	N/A
	N/A
