Access Compliance Report

Public Rights-of-Way

(Curb Ramps)

Intersection ID: 46742	Main Street: HAMILTON_RD	Cross Street: CUMBERLAND_COVE_DR	Location: NE
ADA ID: 17EF6C3A3D33	Ramp Type: PerpDiag	Initial Pass/Fail: Fail	Overall Compliance: No
		Severity Score: 10

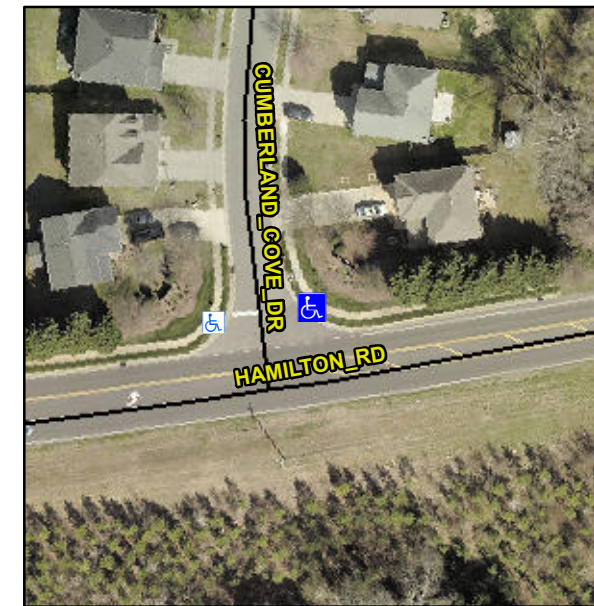
Not Found, R304.5.1, R304.5.3

Compliance	Description	Data	Compliance	Description	Data
N/A	Ramp Length (in)	48.0	Yes	Ramp Slope (%)	6.8
No	Ramp Width (in)	47.0	No	Ramp XSlope (%)	3.6
N/A	Flare Type LT	N/A	N/A	Flare Type RT	N/A
N/A	Flare Slope LT (%)	N/A	N/A	Flare Slope RT (%)	N/A
N/A	Flare Traversable LT?	N/A	N/A	Flare Traversable RT?	N/A
N/A	Landing Length (in)	N/A	N/A	DWS Provided?	N/A
N/A	Landing Width (in)	N/A	N/A	DWS Contrast?	N/A
N/A	Landing Slope (%)	N/A	N/A	DWS Length (in)	N/A
N/A	Landing X Slope (%)	N/A	N/A	DWS Full Width?	N/A
N/A	Landing Curb? (Y/N)	N/A	N/A	DWS Offset (in)	N/A
N/A	Shared Landing?	N/A			
N/A	Gutter Ponding?	N/A	N/A	Gutter Slope (%)	N/A
N/A	Gutter Lip Ht (in)	N/A	N/A	Gutter X Slope (%)	N/A
N/A	Painted X Walk1?	No	N/A	Painted X Walk2?	No
	X Walk 1 Direction	To W		X Walk 2 Direction	To S
N/A	X Walk 1 Width (in)	N/A	N/A	X Walk 2 Width (in)	N/A
	X Walk 1 Slope (%)	2.3		X Walk 2 Slope (%)	0.7
	X Walk 1 X Slope (%)	1.2		X Walk 2 X Slope (%)	2.9

N/A	Ramp inside XWalk1?	N/A	N/A	Ramp inside XWalk2?	N/A
	Road Slope (%)	4.0	N/A	Clear Space?	N/A
	Road X Slope (%)	1.3	N/A	Clear Space to XWalk (in)	N/A
N/A	Any Obstructions?	N/A	N/A	Storm Grate/Utility Hazard?	N/A
	Obstruction Type			Storm Grate/Utility Type	
		N/A			N/A
		Yes		Surface Condition? (G/P)	Good

Remove & Replace Curb Ramp With Two New Directional Ramps or Equivalent.
