# Access Compliance Report

## Public Rights-of-Way

### (Curb Ramps)

| Intersection ID: 22096 | Main Street: COLONY_RD | Cross Street: CARMEL_CRESCENT_DR | Location: SE |

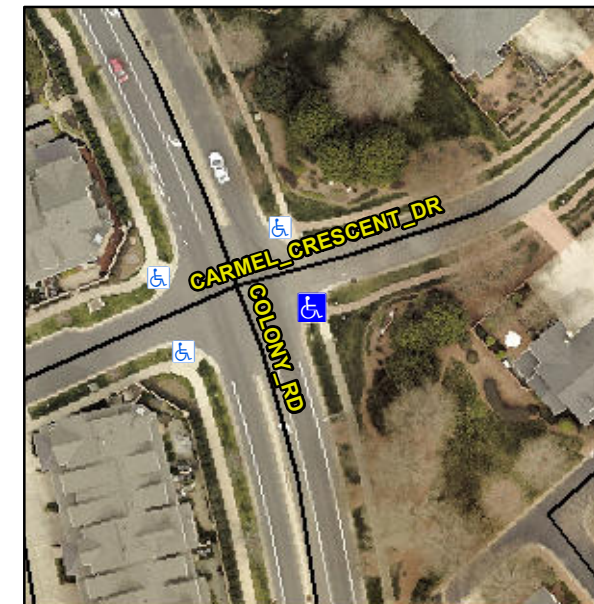
**Not Found, R304.5.3**

| Compliance | Description | Data | Compliance | Description | Data |
|---|---|---|---|---|---|
| N/A | Ramp Length (in) | 87.0 | Yes | Ramp Slope (%) | 6.4 |
| Yes | Ramp Width (in) | 53.0 | No | Ramp XSlope (%) | 5.1 |

**Remove & Replace Curb Ramp With Two New Directional Ramps or Equivalent.**
