Access Compliance Report

Public Rights-of-Way

(Curb Ramps)

Intersection ID: 3163	Main Street: BASKERVILLE_AV	Cross Street: PROSPERITY_CHURCH_RD	Location: NE
ADA ID: 17FC2D66CDC8	Ramp Type: Perp	Initial Pass/Fail: Fail	Overall Compliance: No
Severity Score: 33.75			
Codes/Mitigation Info/Possible Solution		Field Measurements/Component Compliance

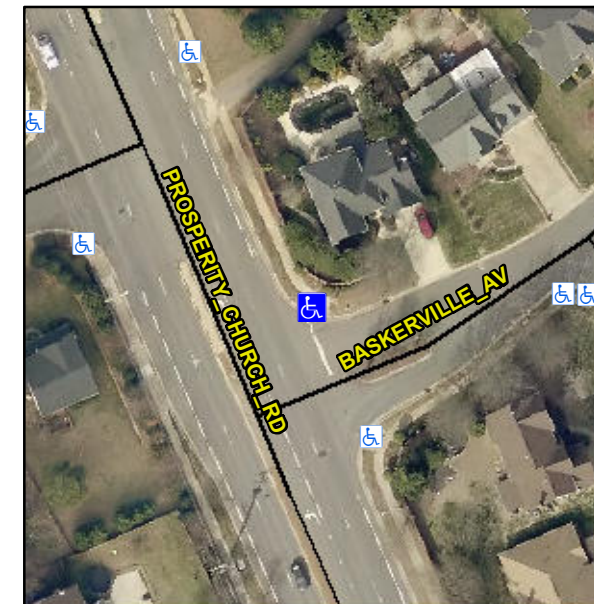
Compliance	Description	Data	Compliance	Description	Data
N/A	Ramp Length (in)	73.0	No	Ramp Slope (%)	20.0
No	Ramp Width (in)	40.0	Yes	Ramp XSlope (%)	1.5
N/A	Flare Type LT	N/A	N/A	Flare Type RT	N/A
N/A	Flare Slope LT (%)	N/A	N/A	Flare Slope RT (%)	N/A
N/A	Flare Traversable LT?	N/A	N/A	Flare Traversable RT?	N/A
N/A	Landing Length (in)	N/A	N/A	DWS Provided?	N/A
N/A	Landing Width (in)	N/A	N/A	DWS Contrast?	N/A
N/A	Landing Slope (%)	N/A	N/A	DWS Length (in)	N/A
N/A	Landing X Slope (%)	N/A	N/A	DWS Full Width?	N/A
N/A	Landing Curb? (Y/N)	N/A	N/A	DWS Offset (in)	N/A
N/A	Shared Landing?	N/A			
N/A	Gutter Ponding?	N/A	N/A	Gutter Slope (%)	N/A
N/A	Gutter Lip Ht (in)	N/A	N/A	Gutter X Slope (%)	N/A
N/A	Painted X Walk1?	No	N/A	Painted X Walk2?	N/A
	X Walk 1 Direction	To S		X Walk 2 Direction	N/A
N/A	X Walk 1 Width (in)	N/A	N/A	X Walk 2 Width (in)	N/A
	X Walk 1 Slope (%)	3.1		X Walk 2 Slope (%)	N/A
	X Walk 1 X Slope (%)	1.7		X Walk 2 X Slope (%)	N/A

Possible Solutions:

Remove & Replace Entire Ramp.

R304.5.1, R304.2.2

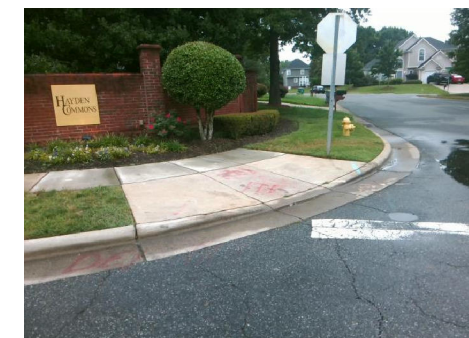
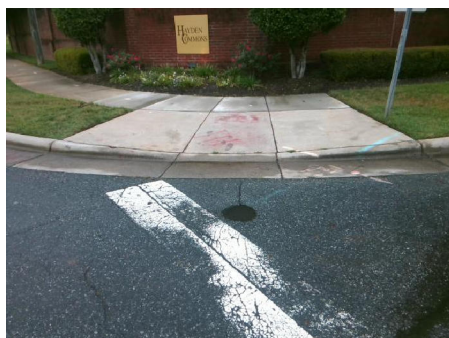
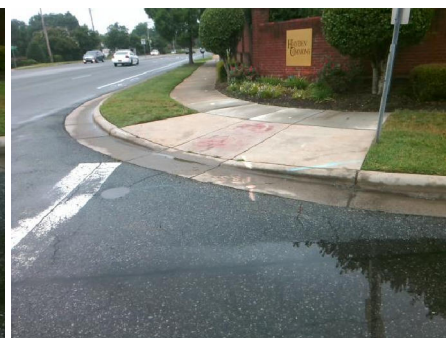
N/A	Ramp inside XWalk1?	N/A	N/A	Ramp inside XWalk2?	N/A
	Road Slope (%)	N/A	N/A	Clear Space?	N/A
	Road X Slope (%)	N/A	N/A	Clear Space to XWalk (in)	N/A
N/A	Any Obstructions?	N/A	N/A	Storm Grate/Utility Hazard?	N/A
	Obstruction Type			Storm Grate/Utility Type	
		N/A			N/A
		Yes		Surface Condition? (G/P)	Good
