Access Compliance Report

Public Rights-of-Way

(Curb Ramps)

Intersection ID: 5501	Main Street: BRACHNELL_VIEW_DR	Cross Street: MALLARD_PARK_DR	Location: E
ADA ID: 17FE3F5143DF	Ramp Type: Perp	Initial Pass/Fail: Fail	Overall Compliance: No
Severity Score: 25			
Codes/Mitigation Info/Possible Solution		Field Measurements/Component Compliance

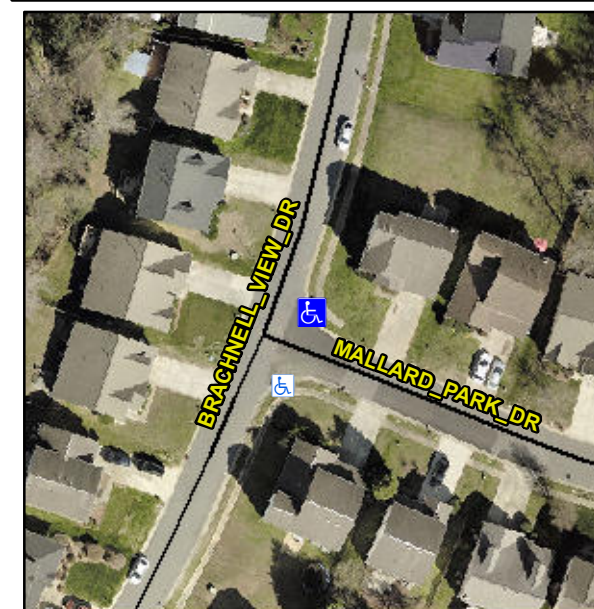
Not Found, R304.5.3

Compliance	Description	Data	Compliance	Description	Data
N/A	Ramp Length (in)	46.0	Yes	Ramp Slope (%)	6.7
Yes	Ramp Width (in)	52.0	No	Ramp XSlope (%)	7.3
N/A	Flare Type LT	N/A	N/A	Flare Type RT	N/A
N/A	Flare Slope LT (%)	N/A	N/A	Flare Slope RT (%)	N/A
N/A	Flare Traversable LT?	N/A	N/A	Flare Traversable RT?	N/A
N/A	Landing Length (in)	N/A	N/A	DWS Provided?	N/A
N/A	Landing Width (in)	N/A	N/A	DWS Contrast?	N/A
N/A	Landing Slope (%)	N/A	N/A	DWS Length (in)	N/A
N/A	Landing X Slope (%)	N/A	N/A	DWS Full Width?	N/A
N/A	Landing Curb? (Y/N)	N/A	N/A	DWS Offset (in)	N/A
N/A	Shared Landing?	N/A			
N/A	Gutter Ponding?	N/A	N/A	Gutter Slope (%)	N/A
N/A	Gutter Lip Ht (in)	N/A	N/A	Gutter X Slope (%)	N/A
N/A	Painted X Walk1?	No	N/A	Painted X Walk2?	N/A
	X Walk 1 Direction	To SW		X Walk 2 Direction	N/A
N/A	X Walk 1 Width (in)	N/A	N/A	X Walk 2 Width (in)	N/A
	X Walk 1 Slope (%)	4.2		X Walk 2 Slope (%)	N/A
	X Walk 1 X Slope (%)	3.9		X Walk 2 X Slope (%)	N/A

N/A	Ramp inside XWalk1?	N/A	N/A	Ramp inside XWalk2?	N/A
	Road Slope (%)	N/A	N/A	Clear Space?	N/A
	Road X Slope (%)	N/A	N/A	Clear Space to XWalk (in)	N/A
N/A	Any Obstructions?	N/A	N/A	Storm Grate/Utility Hazard?	N/A
	Obstruction Type			Storm Grate/Utility Type	
		N/A			N/A
		Yes		Surface Condition? (G/P)	Good

Remove & Replace Entire Ramp.
