# Access Compliance Report

## Public Rights-of-Way

### (Curb Ramps)

| Intersection ID: 30083 | Main Street: J_W_CLAY_BV | Cross Street: VILLAGE_SHOPPING_CENTER_DR | Location: SE |

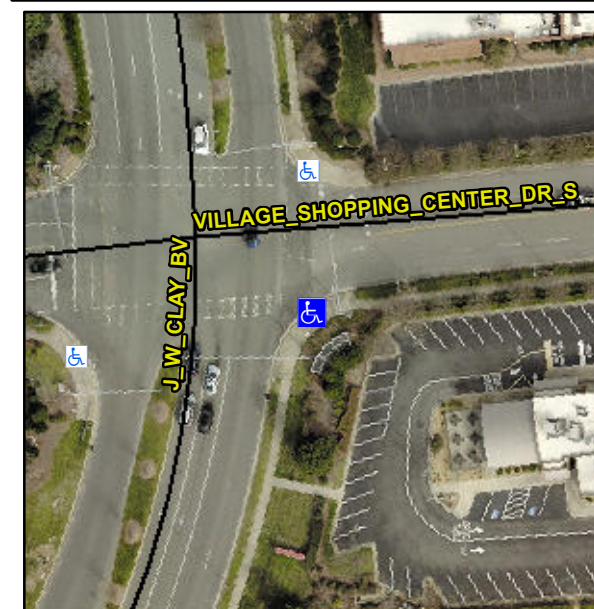
**Not Found, R304.5.1, R304.2.2**

| Compliance | Description | Data | Compliance | Description | Data |
|---|---|---|---|---|---|
| N/A | Ramp Length (in) | 112.0 | No | Ramp Slope (%) | 8.9 |
| No | Ramp Width (in) | 35.5 | Yes | Ramp XSlope (%) | 0.1 |

**Remove & Replace Curb Ramp With Two New Directional Ramps or Equivalent.**

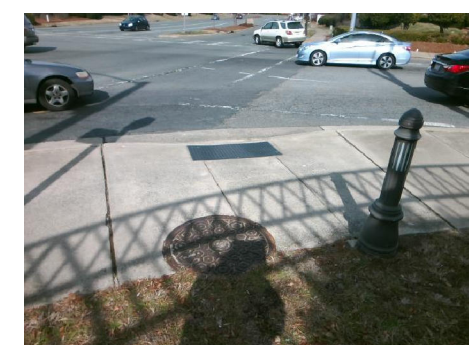
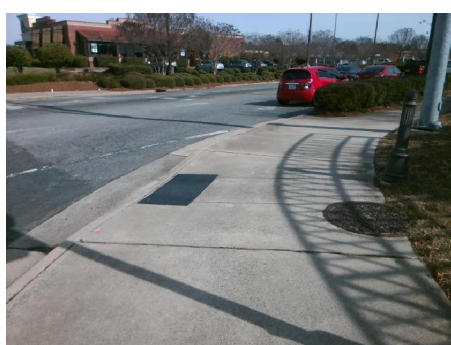
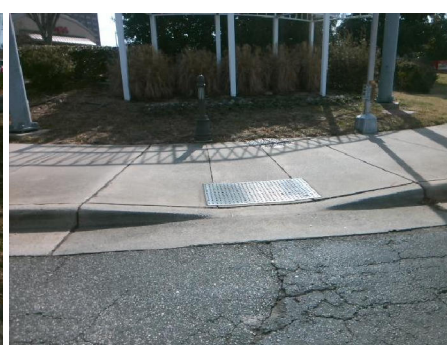
| ADA ID: 180A27F19AD5 | Ramp Type: PerpDiag | Initial Pass/Fail: Fail | Overall Compliance: No |
