Access Compliance Report

Public Rights-of-Way

(Curb Ramps)

Intersection ID: 5980	Main Street: SUTHER_RD	Cross Street: MARGIE_ANN_DR	Location: E
ADA ID: 1818F5785C5E	Ramp Type: PerpDiag	Initial Pass/Fail: Fail	Overall Compliance: No
Severity Score: 12.5			
Codes/Mitigation Info/Possible Solution		Field Measurements/Component Compliance

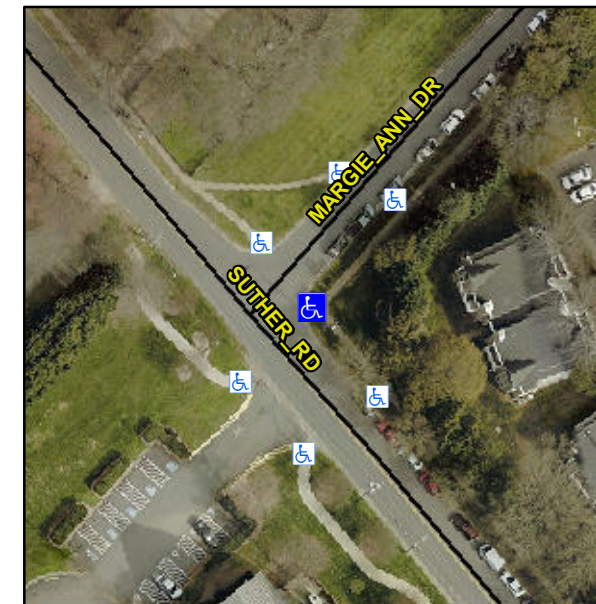
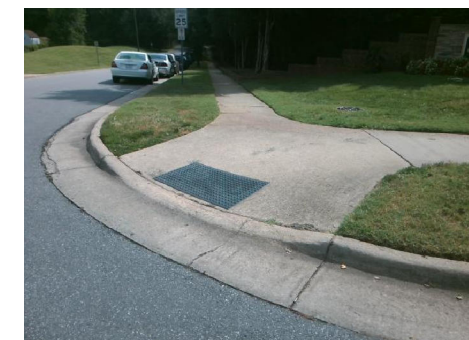
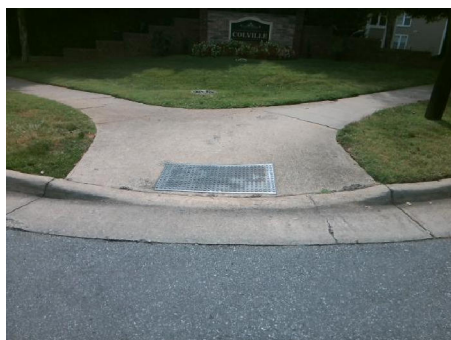
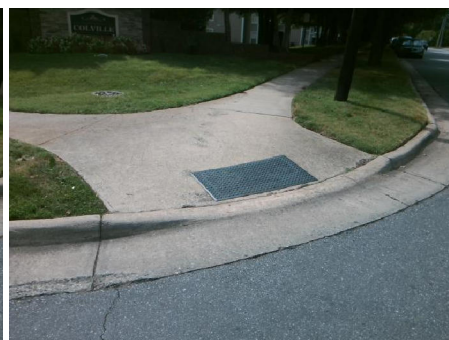
Not Found, R304.5.3

Compliance	Description	Data	Compliance	Description	Data
N/A	Ramp Length (in)	58.0	Yes	Ramp Slope (%)	8.1
Yes	Ramp Width (in)	53.0	No	Ramp XSlope (%)	6.4
N/A	Flare Type LT	N/A	N/A	Flare Type RT	N/A
N/A	Flare Slope LT (%)	N/A	N/A	Flare Slope RT (%)	N/A
N/A	Flare Traversable LT?	N/A	N/A	Flare Traversable RT?	N/A
N/A	Landing Length (in)	N/A	N/A	DWS Provided?	N/A
N/A	Landing Width (in)	N/A	N/A	DWS Contrast?	N/A
N/A	Landing Slope (%)	N/A	N/A	DWS Length (in)	N/A
N/A	Landing X Slope (%)	N/A	N/A	DWS Full Width?	N/A
N/A	Landing Curb? (Y/N)	N/A	N/A	DWS Offset (in)	N/A
N/A	Shared Landing?	N/A			
N/A	Gutter Ponding?	N/A	N/A	Gutter Slope (%)	N/A
N/A	Gutter Lip Ht (in)	N/A	N/A	Gutter X Slope (%)	N/A
N/A	Painted X Walk1?	No	N/A	Painted X Walk2?	No
	X Walk 1 Direction	To NW		X Walk 2 Direction	To SW
N/A	X Walk 1 Width (in)	N/A	N/A	X Walk 2 Width (in)	N/A
	X Walk 1 Slope (%)	2.2		X Walk 2 Slope (%)	5.7
	X Walk 1 X Slope (%)	4.2		X Walk 2 X Slope (%)	0.6

N/A	Ramp inside XWalk1?	N/A	N/A	Ramp inside XWalk2?	N/A
	Road Slope (%)	3.3	N/A	Clear Space?	N/A
	Road X Slope (%)	3.6	N/A	Clear Space to XWalk (in)	N/A
N/A	Any Obstructions?	N/A	N/A	Storm Grate/Utility Hazard?	N/A
	Obstruction Type			Storm Grate/Utility Type	
		N/A			N/A
		Yes		Surface Condition? (G/P)	Good

Remove & Replace Curb Ramp With Two New Directional Ramps or Equivalent.
