Access Compliance Report Public Rights-of-Way (Curb Ramps)

Intersection ID: 47227 Main Street: VALLEYDALE RD **Cross Street: OAKSHIRE CR** Location: Ε ADA ID: 18306FC915F8 Ramp Type: PerpDiag Initial Pass/Fail: Fail **Overall Compliance: No Severity Score:** 25

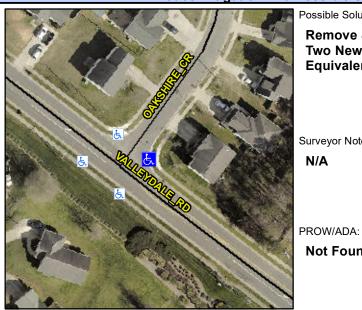
Field Measurements/Component Compliance						
Compliance Description		Data	Compl	liance	Description	Data
N/A	Ramp Length (in)	51.0	Yes	Ramp	Slope (%)	5.2
Yes	Ramp Width (in)	55.0	No	Ramp	XSlope (%)	7.5
N/A	Flare Type LT	N/A	N/A	Flare	Гуре RT	N/A
N/A	Flare Slope LT (%)	N/A	N/A	Flare	Slope RT (%)	N/A
N/A	Flare Traversable LT?	N/A	N/A	Flare	Traversable RT?	N/A
N/A	Landing Length (in)	N/A	N/A	DWS	Provided?	N/A
N/A	Landing Width (in)	N/A	N/A	DWS	Contrast?	N/A
N/A	Landing Slope (%)	N/A	N/A	DWS	Length (in)	N/A
N/A	Landing X Slope (%)	N/A	N/A	DWS	Full Width?	N/A
N/A	Landing Curb? (Y/N)	N/A	N/A	DWS	Offset (in)	N/A
N/A	Shared Landing?	N/A				
N/A	Gutter Ponding?	N/A	N/A	Gutter	Slope (%)	N/A
N/A	Gutter Lip Ht (in)	N/A	N/A	Gutter	X Slope (%)	N/A
N/A	Painted X Walk1?	No	N/A	Painte	d X Walk2?	No
	X Walk 1 Direction	To NW		X Wall	k 2 Direction	To SW
N/A	X Walk 1 Width (in)	N/A	N/A	X Wall	k 2 Width (in)	N/A
	X Walk 1 Slope (%)	0.3		X Wall	k 2 Slope (%)	5.5

X Walk 1 X Slope (%)	2.8		X Wall	k 2 X Slope (%)	3.0
N/A	Ramp inside XWalk1?	N/A	N/A	Ramp	inside XWalk2?	N/A
	Road Slope (%)	5.3	N/A	Clear	Space?	N/A
	Road X Slope (%)	0.8	N/A	Clear	Space to XWalk (in)	N/A
N/A	Any Obstructions?	N/A	N/A	Storm	Grate/Utility Hazard?	N/A
	Obstruction Type			Storm	Grate/Utility Type	
		N/A				N/A
			Yes	Surfac	e Condition? (G/P)	Good

Possible Solutions: Remove & Replace Curb Ramp With Two New Directional Ramps or Equivalent. Surveyor Notes:

Not Found, R304.5.3
