# Access Compliance Report

## Public Rights-of-Way

### (Curb Ramps)

Intersection ID: 46492	Main Street: SHOPTON_RD_WEST	Cross Street: CASTLECOVE_RD	Location:	N
ADA ID: 1837CAD9A902	Ramp Type: PerpDiag	Initial Pass/Fail: Fail	Overall Compliance: No	Severity Score: 22.5
Codes/Mitigation Info/Possible Solution		Field Measurements/Component Compliance

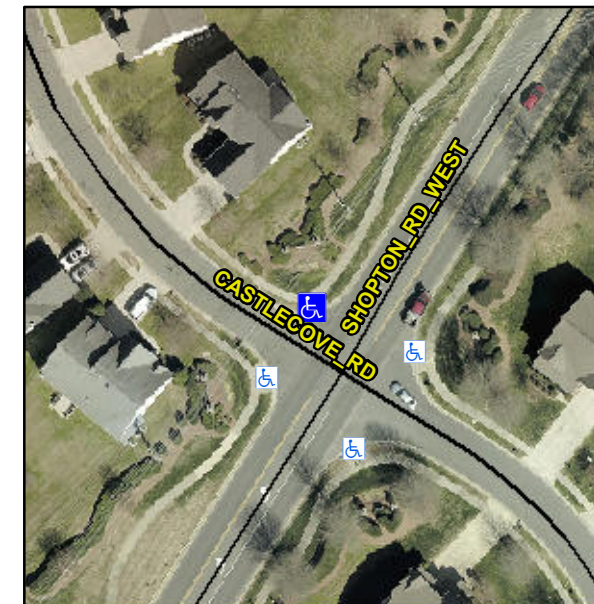
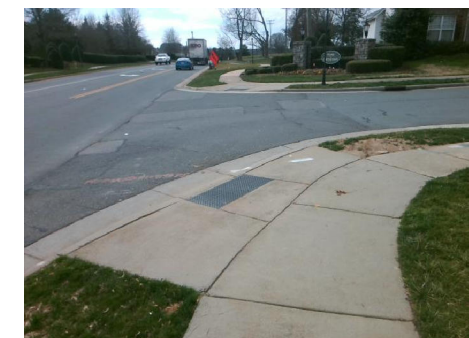
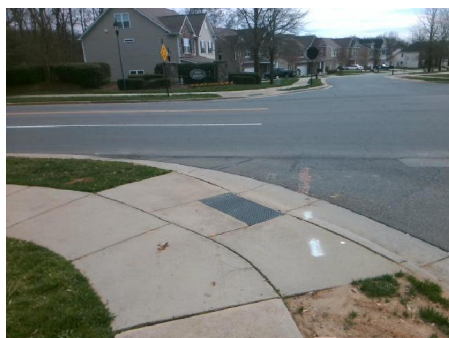
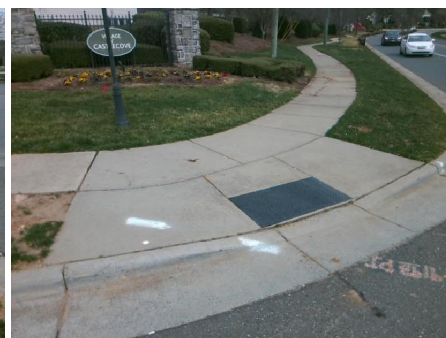
**R304.5.1, R304.2.2, R304.5.3**

Compliance	Description	Data	Compliance	Description	Data
N/A	Ramp Length (in)	49.0	No	Ramp Slope (%)	9.7
No	Ramp Width (in)	41.0	No	Ramp XSlope (%)	3.7
N/A	Flare Type LT	N/A	N/A	Flare Type RT	N/A
N/A	Flare Slope LT (%)	N/A	N/A	Flare Slope RT (%)	N/A
N/A	Flare Traversable LT?	N/A	N/A	Flare Traversable RT?	N/A
N/A	Landing Length (in)	N/A	N/A	DWS Provided?	N/A
N/A	Landing Width (in)	N/A	N/A	DWS Contrast?	N/A
N/A	Landing Slope (%)	N/A	N/A	DWS Length (in)	N/A
N/A	Landing X Slope (%)	N/A	N/A	DWS Full Width?	N/A
N/A	Landing Curb? (Y/N)	N/A	N/A	DWS Offset (in)	N/A
N/A	Shared Landing?	N/A			
N/A	Gutter Ponding?	N/A	N/A	Gutter Slope (%)	N/A
N/A	Gutter Lip Ht (in)	N/A	N/A	Gutter X Slope (%)	N/A
N/A	Painted X Walk1?	No	N/A	Painted X Walk2?	No
	X Walk 1 Direction	To SW		X Walk 2 Direction	To SE
N/A	X Walk 1 Width (in)	N/A	N/A	X Walk 2 Width (in)	N/A
	X Walk 1 Slope (%)	0.2		X Walk 2 Slope (%)	6.2
	X Walk 1 X Slope (%)	4.6		X Walk 2 X Slope (%)	2.1

N/A	Ramp inside XWalk1?	N/A	N/A	Ramp inside XWalk2?	N/A
	Road Slope (%)	2.4	N/A	Clear Space?	N/A
	Road X Slope (%)	3.6	N/A	Clear Space to XWalk (in)	N/A
N/A	Any Obstructions?	N/A	N/A	Storm Grate/Utility Hazard?	N/A
	Obstruction Type			Storm Grate/Utility Type	
		N/A			N/A
			Yes	Surface Condition? (G/P)	Good

**Remove & Replace Curb Ramp With Two New Directional Ramps or Equivalent.**
