Access Compliance Report

Public Rights-of-Way

(Curb Ramps)

| Intersection ID: 18012 | Main Street: RAMA_RD | Cross Street: CHARING_PL | Location: SW |

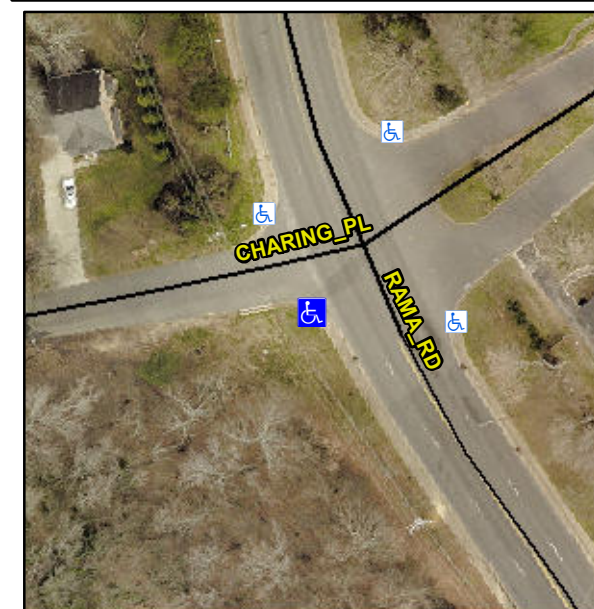
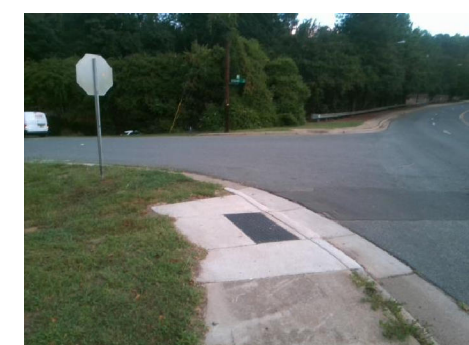
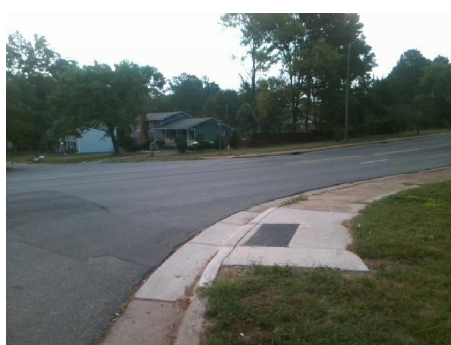
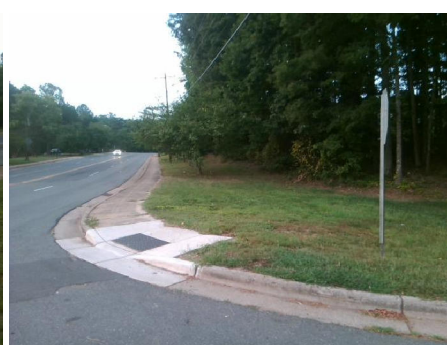
| ADA ID: 18437AE190D4 | Ramp Type: PerpDiag | Initial Pass/Fail: Fail | Overall Compliance: No |
| Severity Score: 21.25 | | | |

Not Found, R304.5.1, R304.2.2

| Compliance | Description | Data | Compliance | Description | Data |
|---|---|---|---|---|---|
| N/A | Ramp Length (in) | 60.5 | No | Ramp Slope (%) | 10.5 |
| No | Ramp Width (in) | 47.5 | Yes | Ramp XSlope (%) | 0.3 |

Remove & Replace Curb Ramp With Two New Directional Ramps or Equivalent.
